# Evaluation of Critical Flare Rates for the Midwest Guardrail System

*Midwest States' Regional Pooled Fund Research Program  
Fiscal Years 2003-2005 (Years 14 and 15)  
Research Project Number SPR-3(017)  
NDOR Sponsoring Agency Code RFPF-04-03 and RFPF-05-05*

# **EVALUATION OF CRITICAL FLARE RATES FOR THE MIDWEST GUARDRAIL SYSTEM (MGS)**

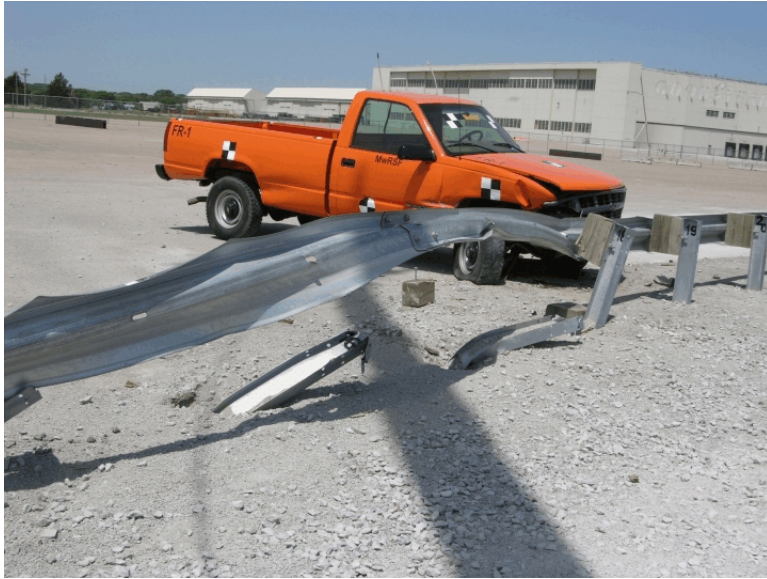
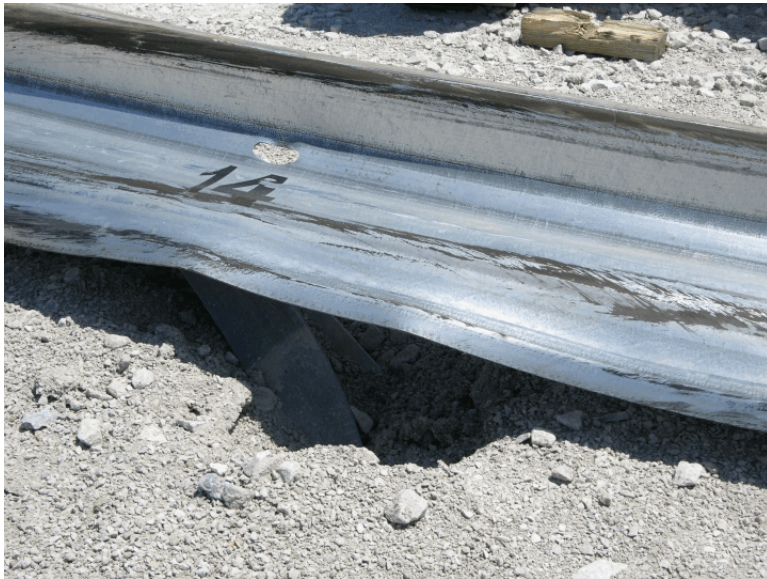
Figure 40. System Damage, Test FR-1

Barrier damage was moderate, as shown in Figures 39 through 44. Barrier damaged consisted of deformed guardrail posts, deformed W-beam rail, deformed and disengaged blockouts, and contact marks on a guardrail section. The length of vehicle contact along the system was approximately 11.4 m (37 ft - 6 in.), which spanned from the centerline of post no. 12 through the centerline of post no. 18.

Moderate deformation and flattening of the impacted section of W-beam rail occurred between post nos. 12 and 18. Contact marks were found on the rail between post nos. 12 and 18. The guardrail buckled at nearly every post location between post nos. 12 and 18. Major buckling of the guardrail occurred at the upstream side of post no. 19. The W-beam was pulled off of post nos. 1 through 19. The W-beam rail sustained significant yielding around the post bolt slots at post nos. 1 through 11, 13, 14, 18, and 19. Minor tearing of the W-beam rail occurred around the post bolt slots at post nos. 12 and 15, while the tearing of the W-beam rail around the post bolt slots at post nos. 16 and 17 was very significant. No significant guardrail damage occurred downstream of post no. 20.

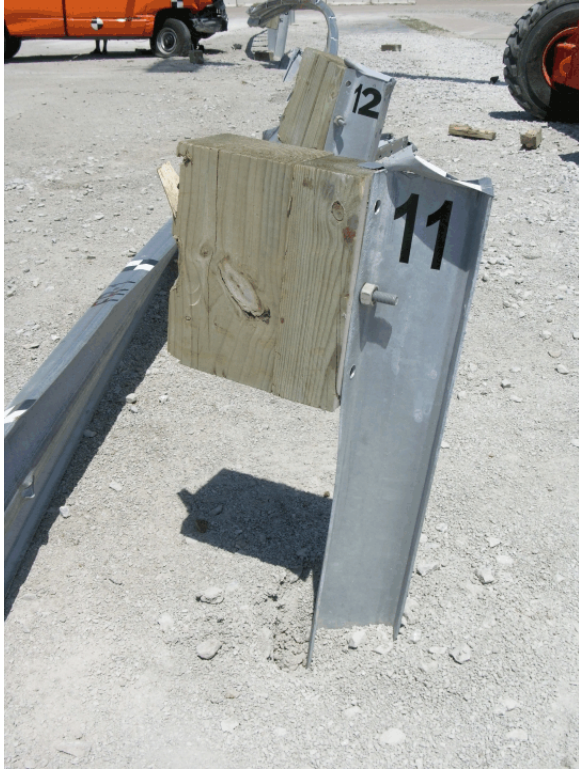
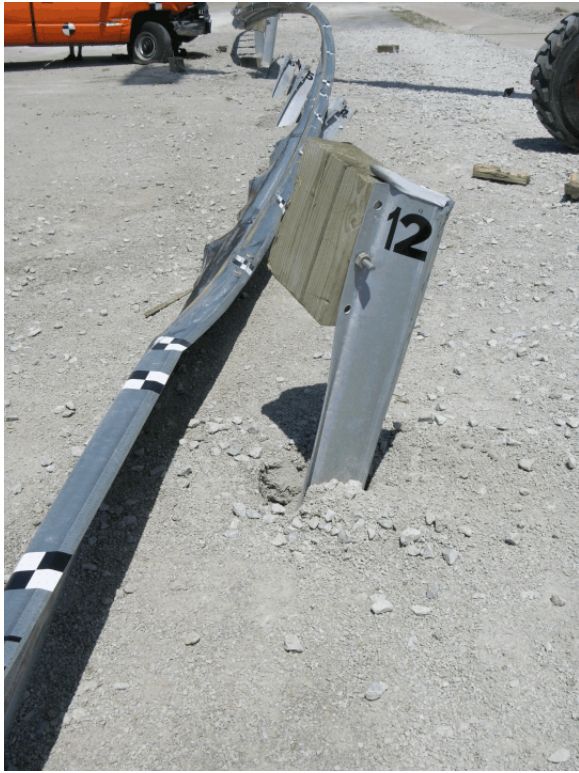
Figure 41. Post Nos. 11 and 12 Damage, Test No. FR-1

The wooden blockouts at post nos. 3 through 10 and 19 rotated slightly while still attached to the post. The wooden blockouts at post nos. 11, 12, and 18 encountered damage on the front face due to W-beam rail contact, but remained attached to the posts. The wooden blockouts at post nos. 13 through 17 were fractured and removed from the posts.

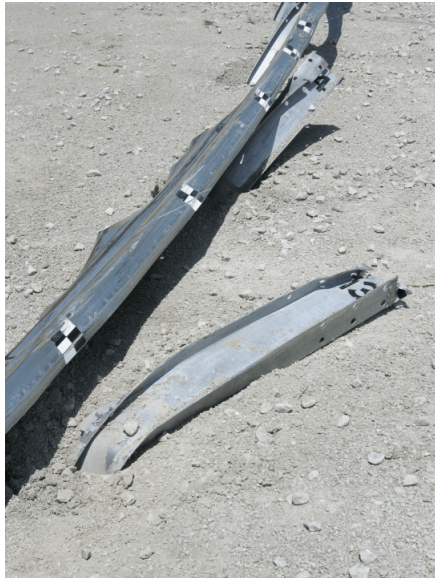
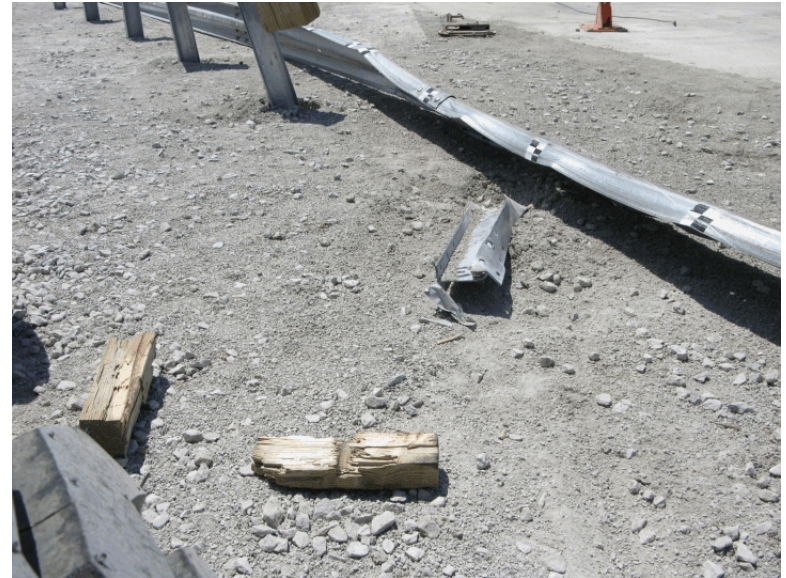
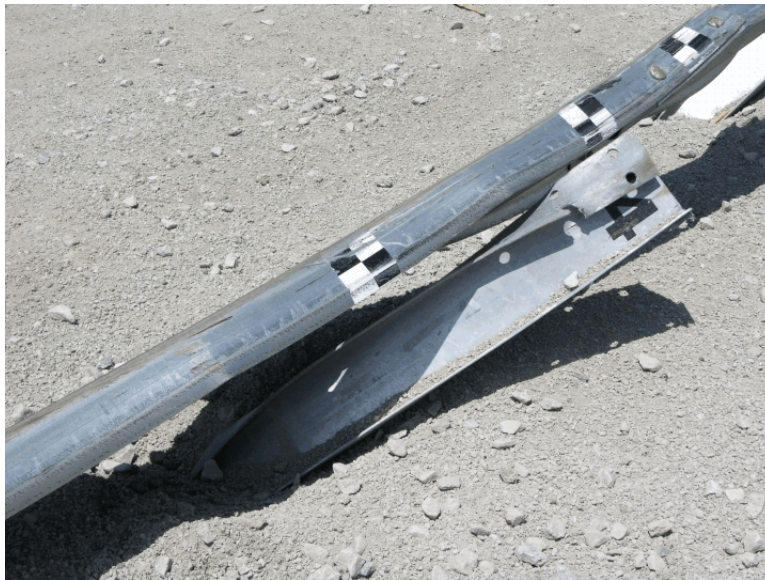
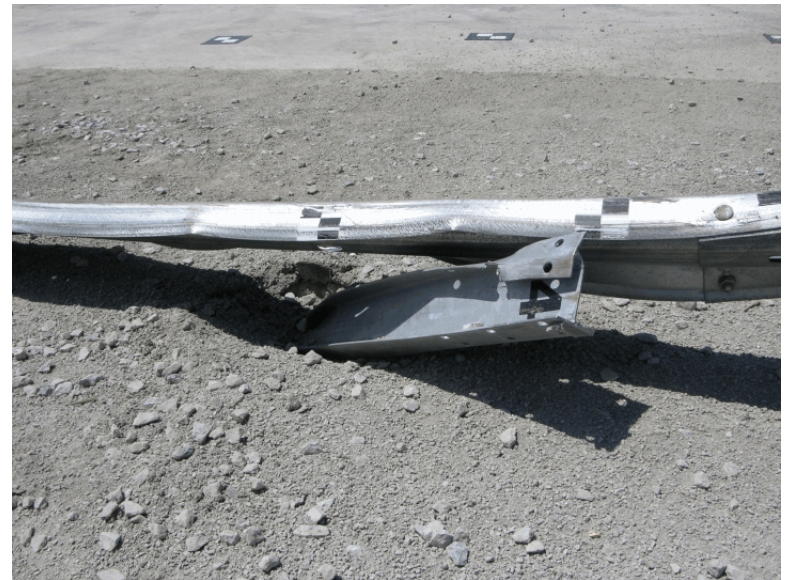
Figure 42. Post Nos. 13 and 14 Damage, Test No. FR-1

The permanent set of the barrier system is shown in Figure 39. The maximum lateral permanent set rail and post deflections were 1,140 mm (44.875 in.) at the midspan between post nos. 15 and 16 and 813 mm (32 in.) at the centerline of post no. 13, respectively, as measured in the field. The maximum lateral dynamic rail and post deflections were 1,684 mm (66.3 in.) at the centerline of post no. 15 and 853 mm (33.6 in.) at the centerline of post no. 13, respectively, as determined from high-speed video analysis. The working width of the system was found to be 1,794 mm (70.6 in.).

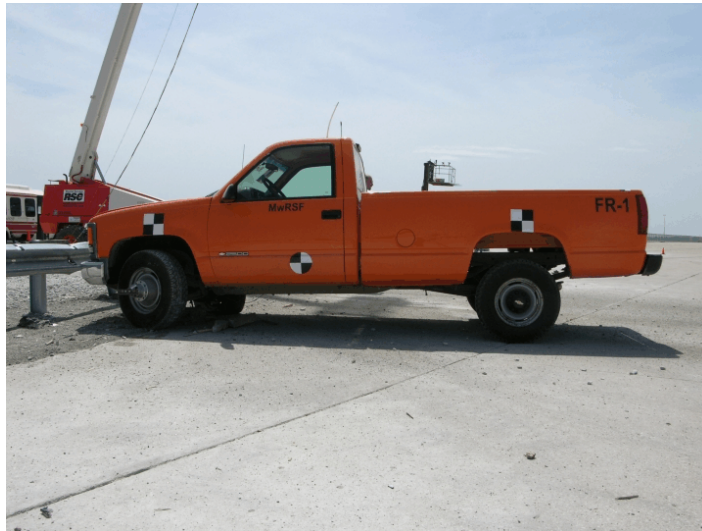
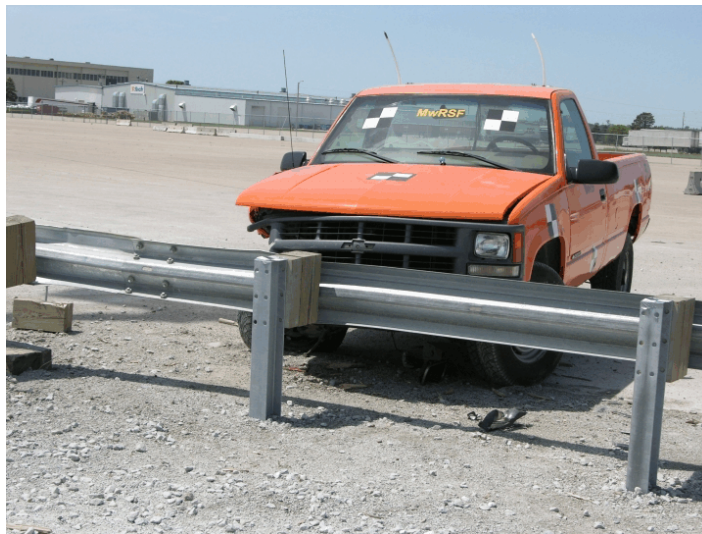
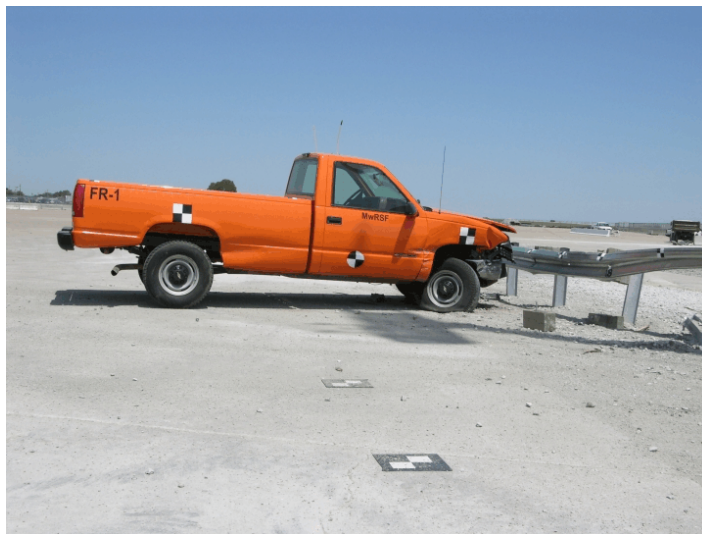
Figure 46. Vehicle Damage, Test FR-1

Exterior vehicle damage was moderate, as shown in Figures 46 through 49. Occupant compartment deformations to the right side and center of the floorboard were judged insufficient to cause serious injury to the vehicle occupants. Maximum longitudinal deflections of 6 mm (0.25 in.) were located near the front and left sides of the right-side floorpan. Maximum lateral deflections of 13 mm (0.5 in.) were located near the center of the right-side floorpan. Maximum vertical deflections of 19 mm (0.75 in.) were located near the right side of the right-side floorpan. Complete occupant compartment deformations and the corresponding locations are provided in Appendix C.

Damage was concentrated on the right-front corner of the vehicle. The right-front bumper

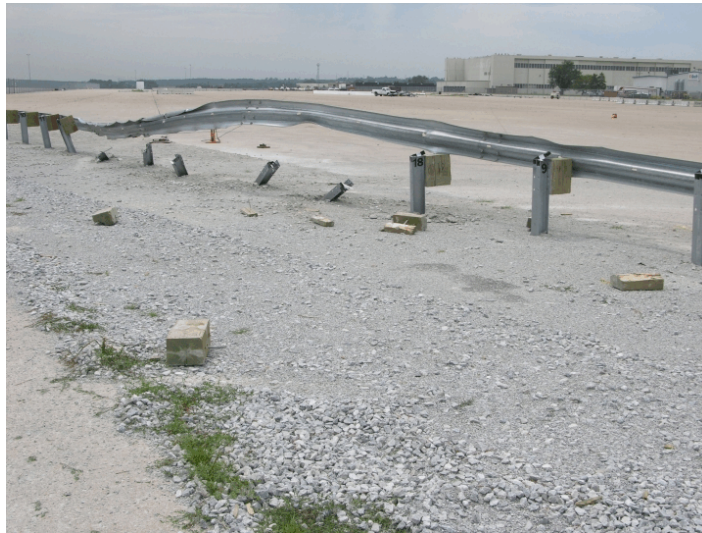
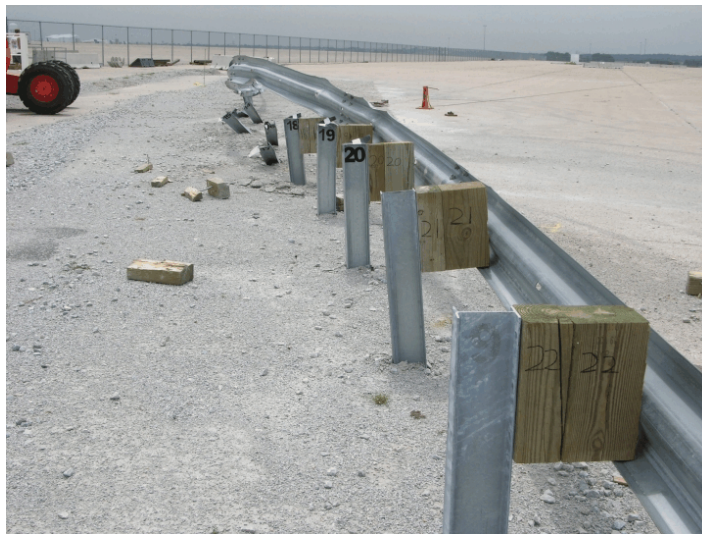
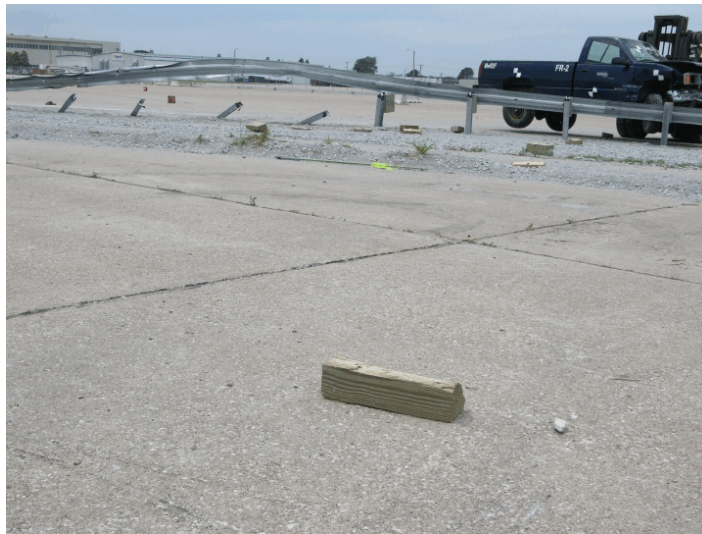
Figure 61. System Damage, Test FR-2

Damage to the barrier system was moderate, as shown in Figures 61 through 69. Barrier damage consisted of deformed guardrail posts, deformed W-beam rail, deformed and disengaged blockouts, and contact marks on a guardrail section. The length of vehicle contact along the system was approximately 16.3 m (53 ft - 6.75 in.), which spanned from 451 mm (17.75 in.) upstream from the centerline of post no. 12 through 635 mm (25 in.) downstream from the centerline of post no. 20.

The permanent set of the barrier system is shown in Figures 61 and 62. The maximum lateral permanent set rail and post deflections were 1,156 mm (45.5 in.) at the midspan between post nos.

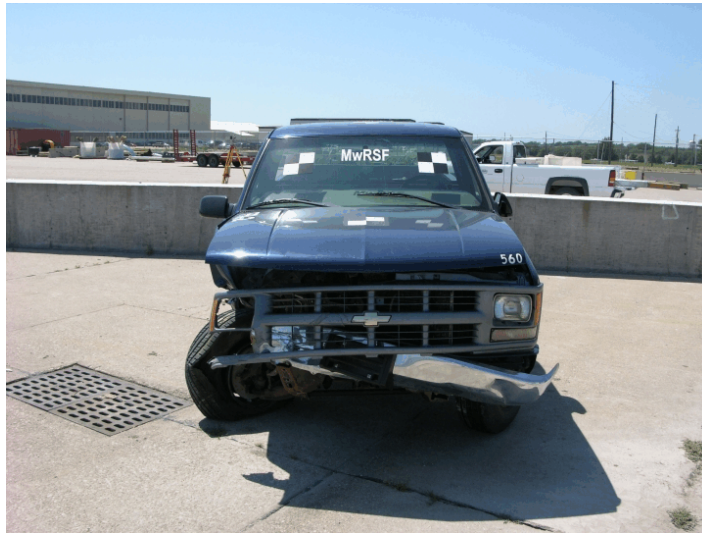
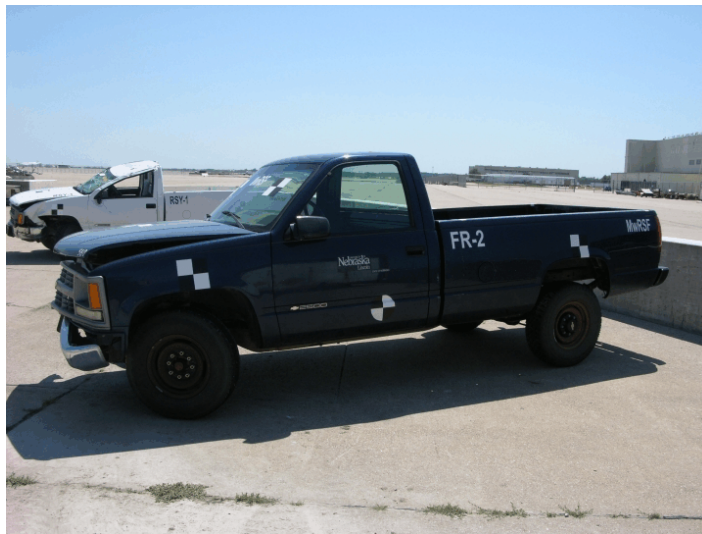
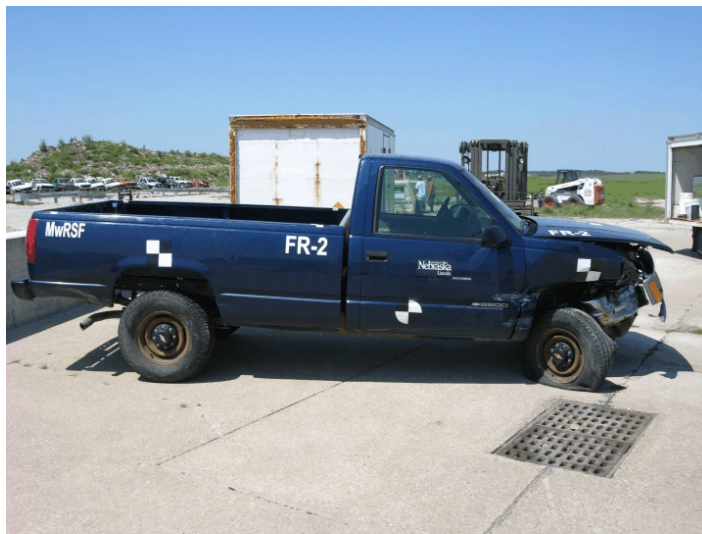
Figure 71. Vehicle Damage, Test FR-2

Exterior vehicle damage was moderate, as shown in Figures 71 through 74. Occupant compartment deformations to the right side and center of the floorboard were judged insufficient to cause serious injury to the vehicle occupants. Maximum longitudinal deflections of 6 mm (0.25 in.) were located along the left side of the right-side floorpan. Maximum lateral deflections of 13 mm (0.5 in.) were located near the left-front corner of the right-side floorpan. Maximum vertical deflections of 6 mm (0.25 in.) were located near the center of the right-side floorpan. Complete occupant compartment deformations and the corresponding locations are provided in Appendix F.

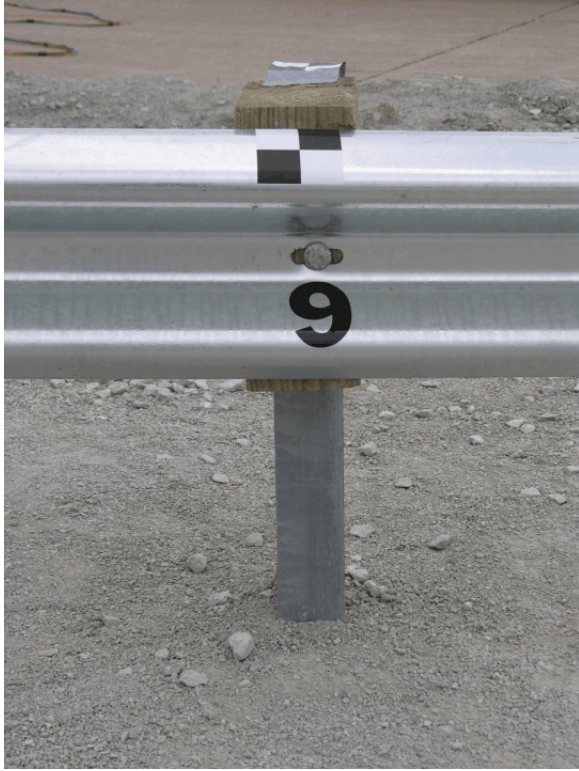
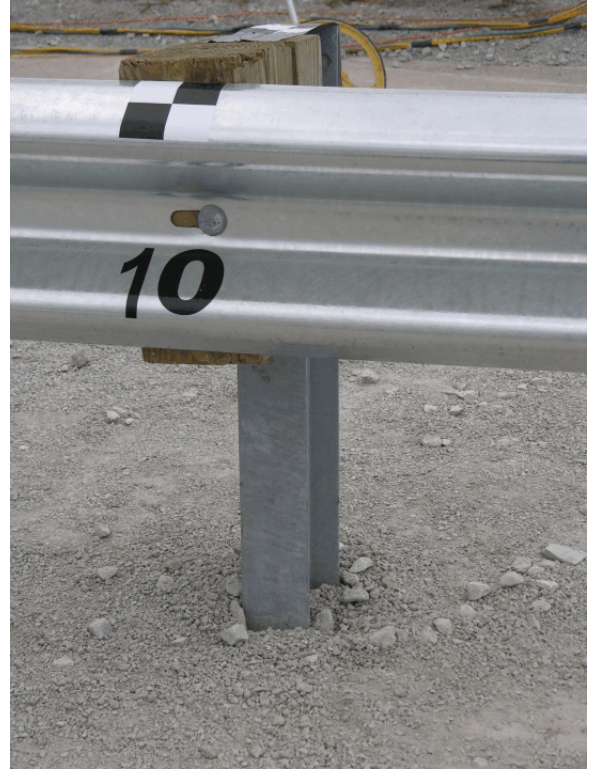
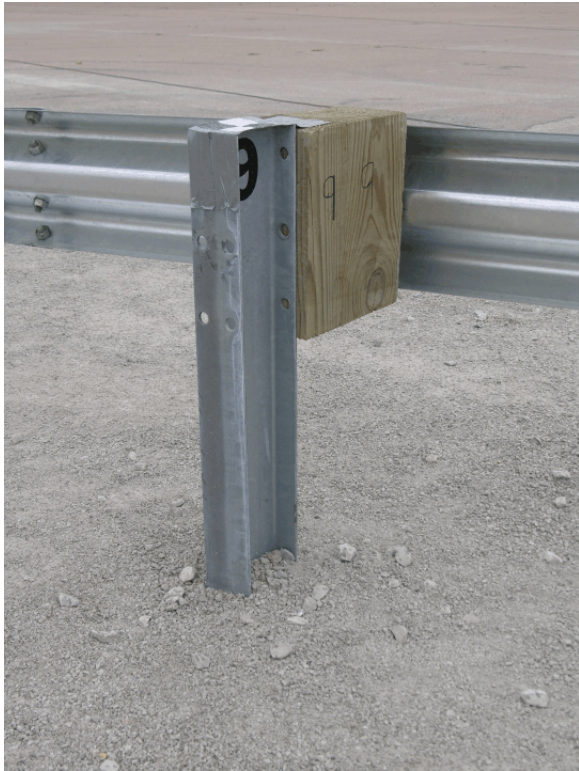
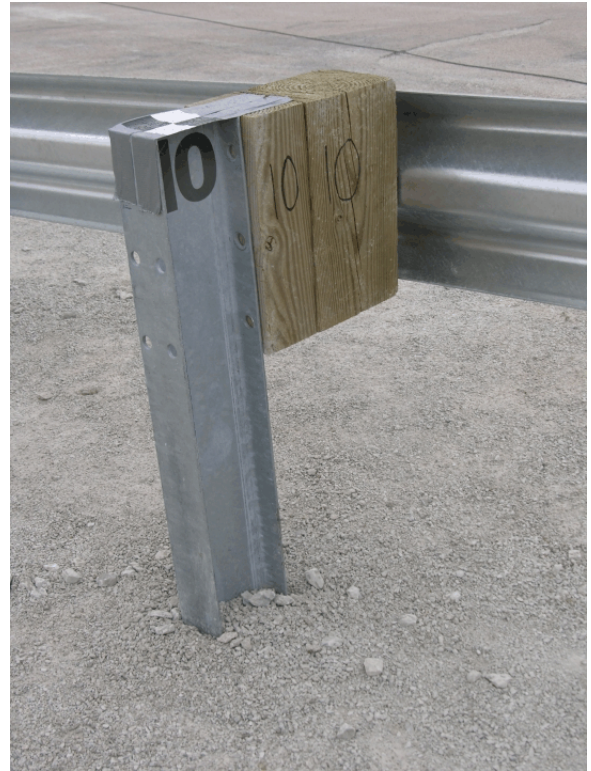
Figure 84. Post Nos. 9 and 10 Damage, Test FR-3

Contact marks were found along the length of vehicle contact with the system. The W-beam rail was deformed and flattened between post nos. 11 and 15. The guardrail buckled at the midspan between post nos. 10 and 11, at post nos. 12 and 15, and at the midspan between post nos. 13 and 14. The guardrail also buckled at 648 mm (25.5 in.) downstream of post no. 12, at 254 mm (10 in.) and 356 mm (14 in.) upstream of post no. 13, and at 191 mm (7.5 in.) and 419 mm (16.5 in.) downstream of post no. 13. Guardrail buckle points were also found at 227 mm (9 in.) upstream of post no. 14, at 286 mm (11.25 in.) and 184 mm (7.25 in.) upstream of post no. 15, and 483 mm (19 in.) downstream of post no. 15. The W-beam was pulled off of post nos. 13 and 14. Minor yielding occurred around the post bolt slots at post nos. 12 through 15. No significant damage occurred downstream of post no. 16, except for slight deflection and minor contact marks between post nos. 25 and 28 due to the secondary vehicle contact with the system before coming to rest.

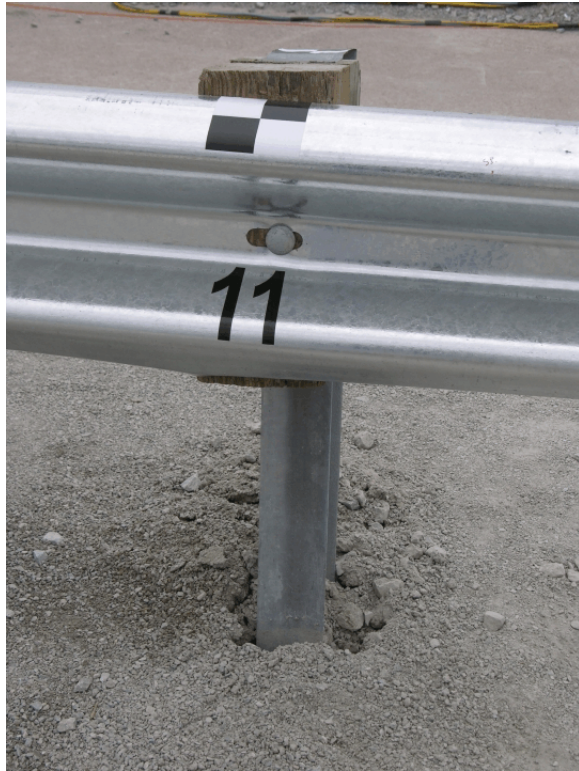
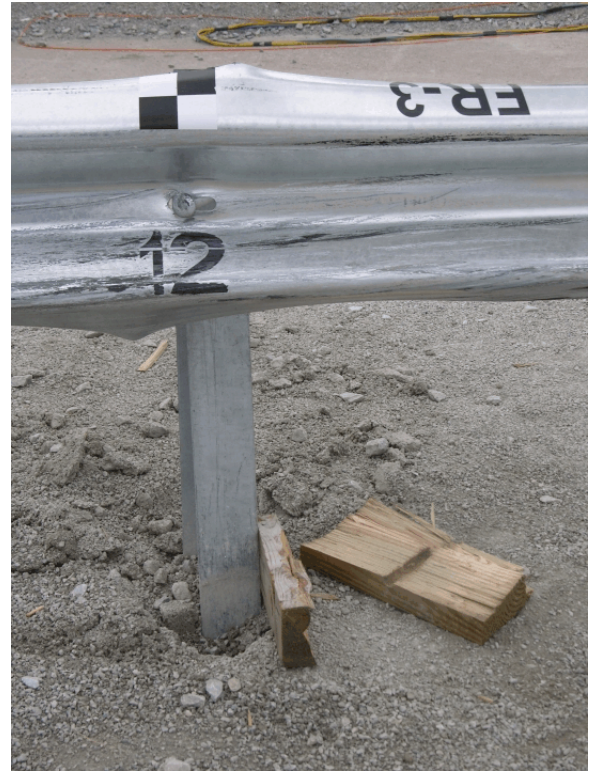
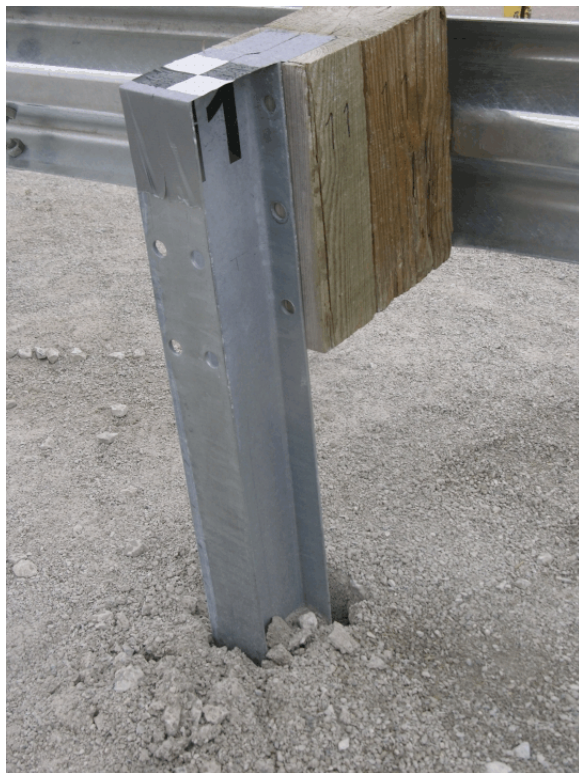
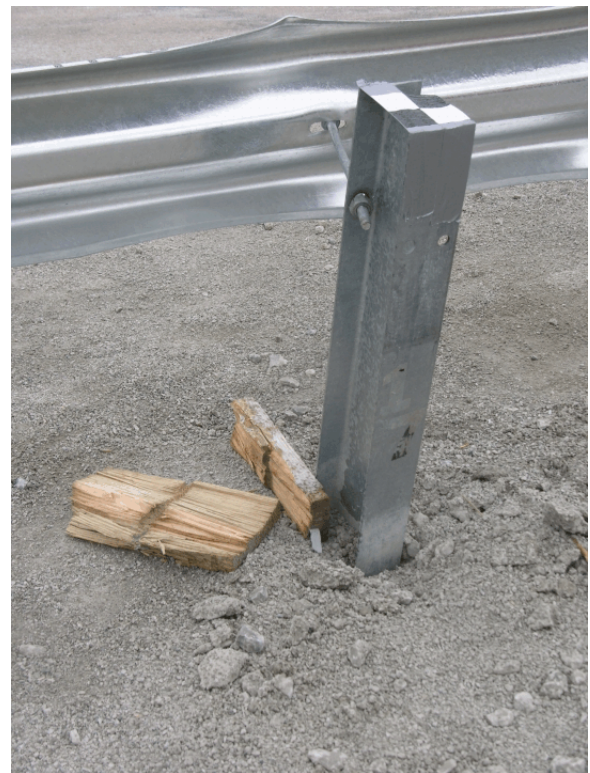
Figure 85. Post Nos. 11 and 12 Damage, Test FR-3

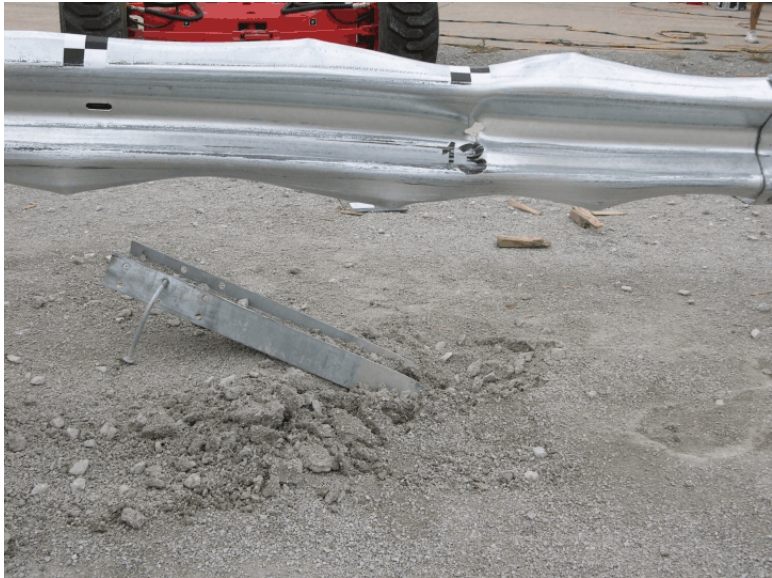
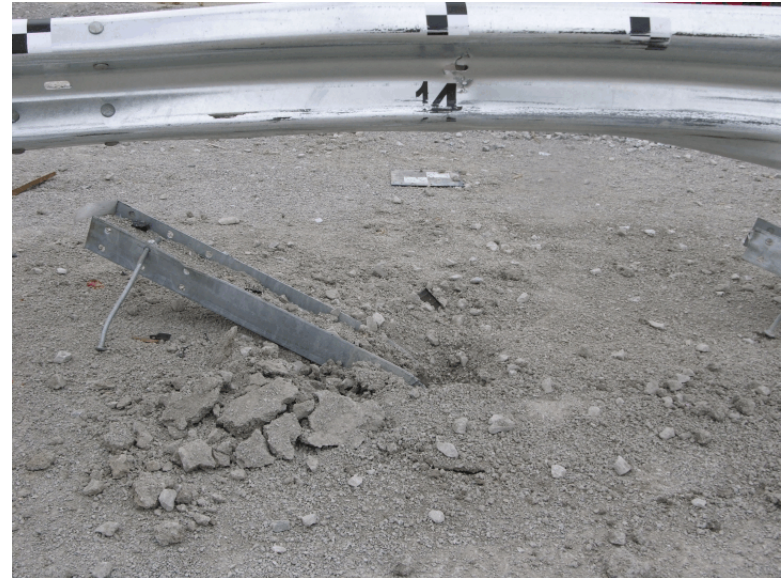
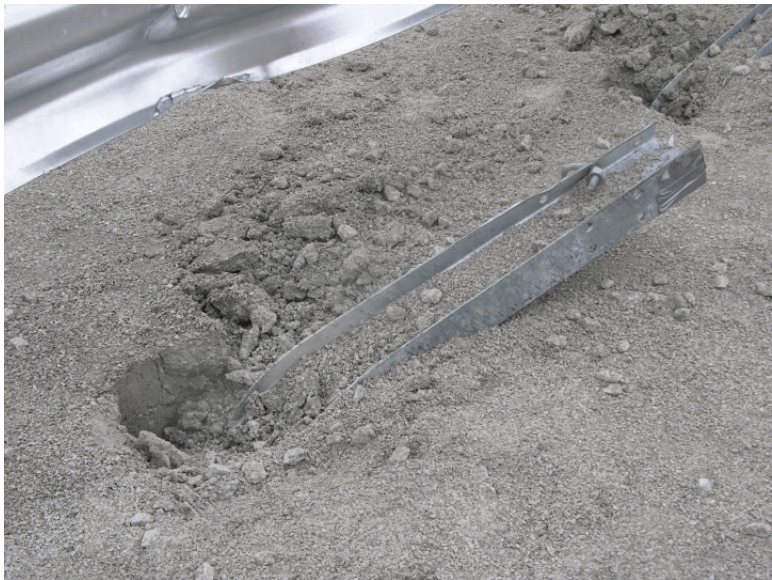
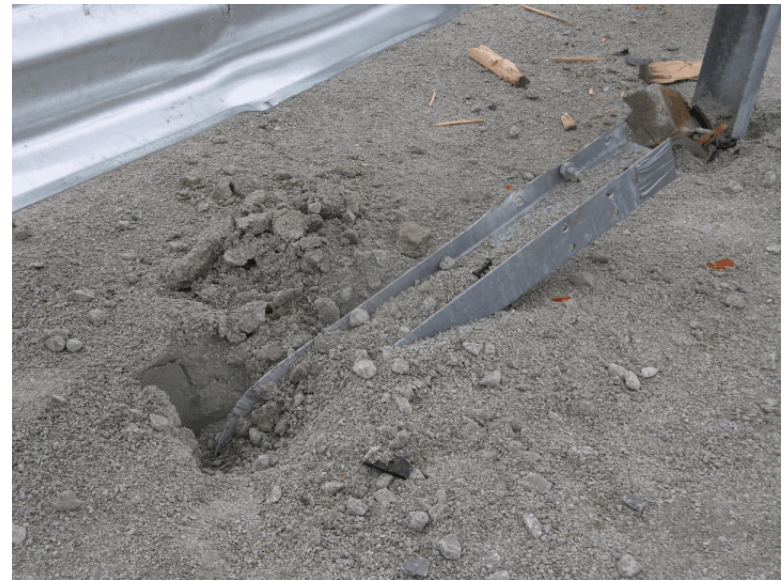
Figure 86. Post Nos. 13 and 14 Damage, Test FR-3

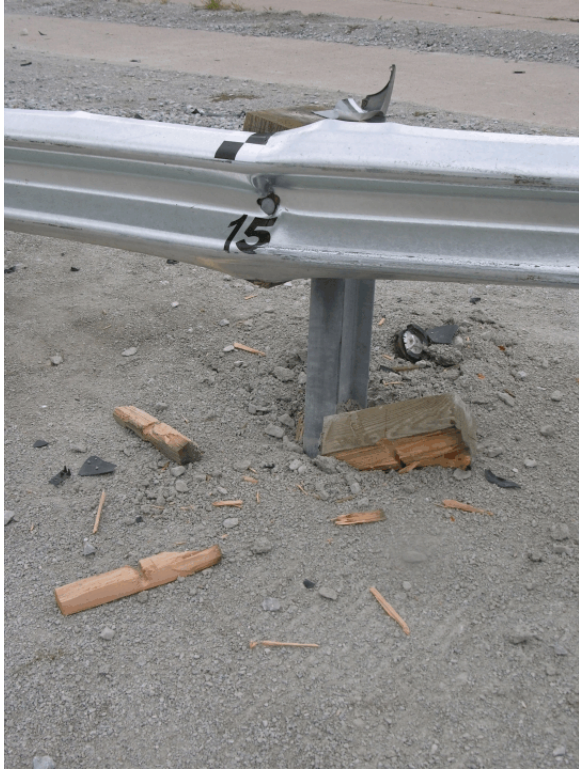
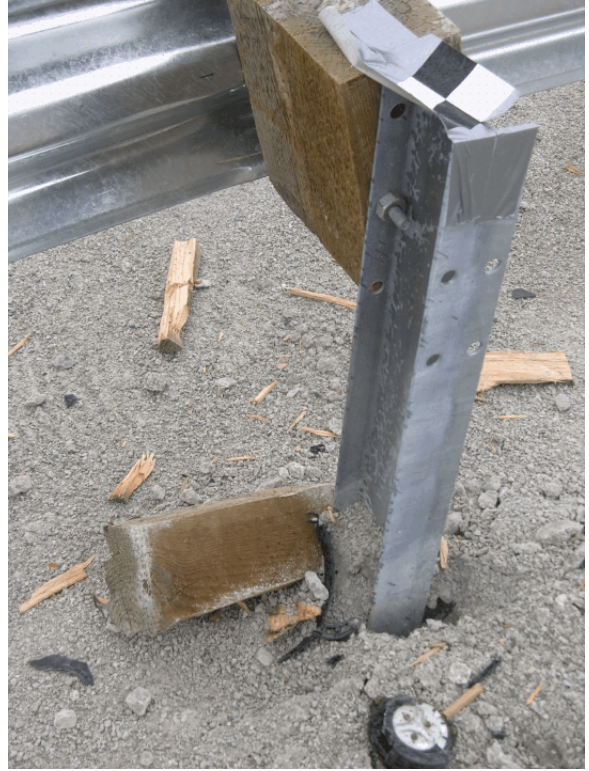
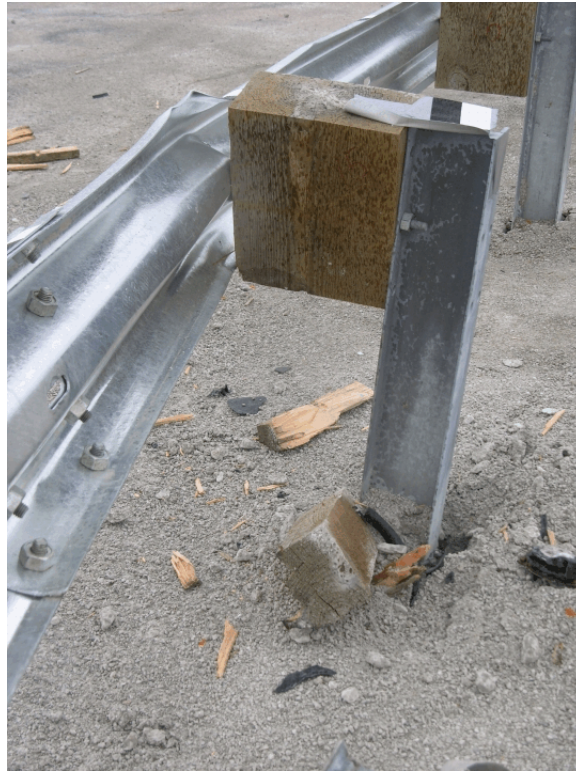
Figure 87. Post No. 15 Damage, Test FR-3

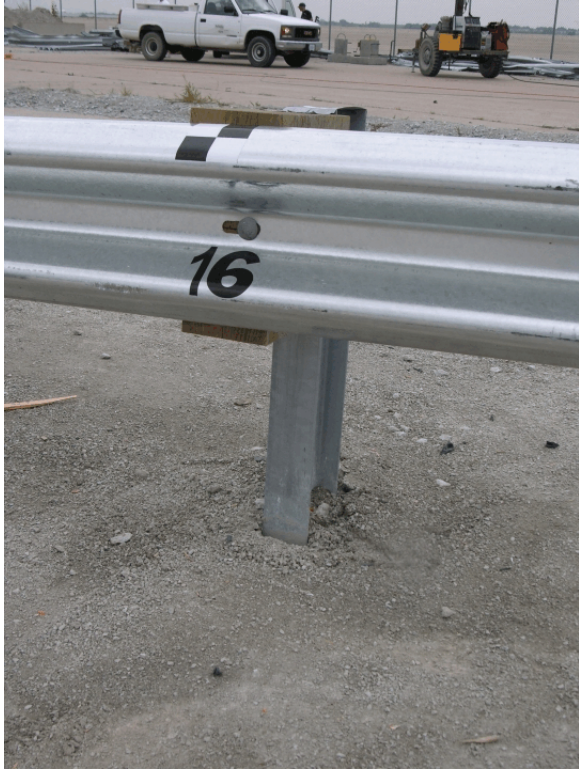
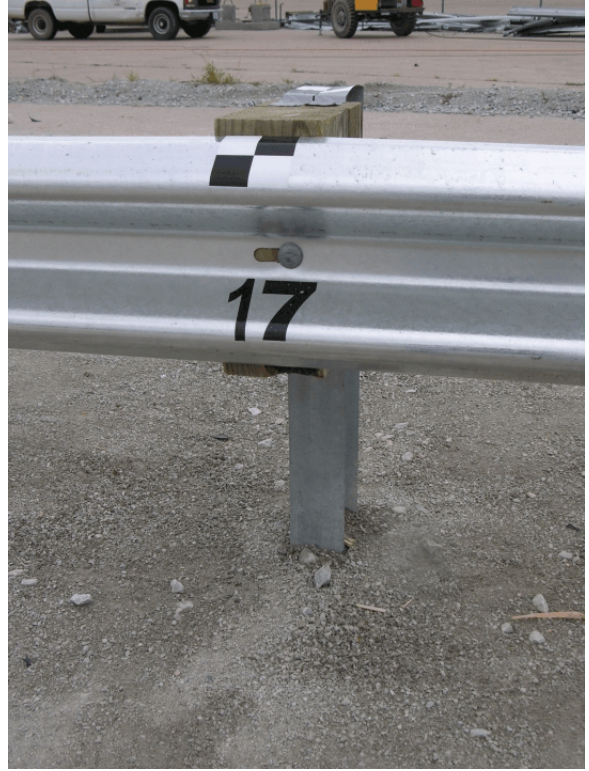
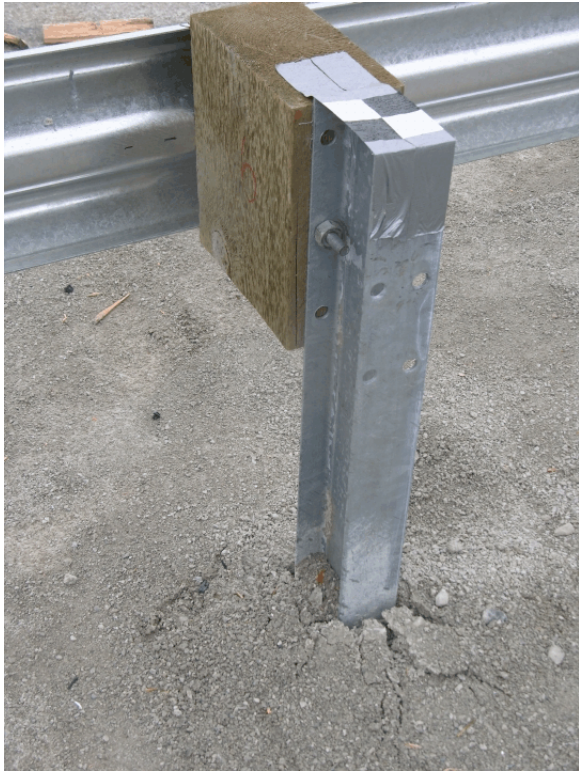
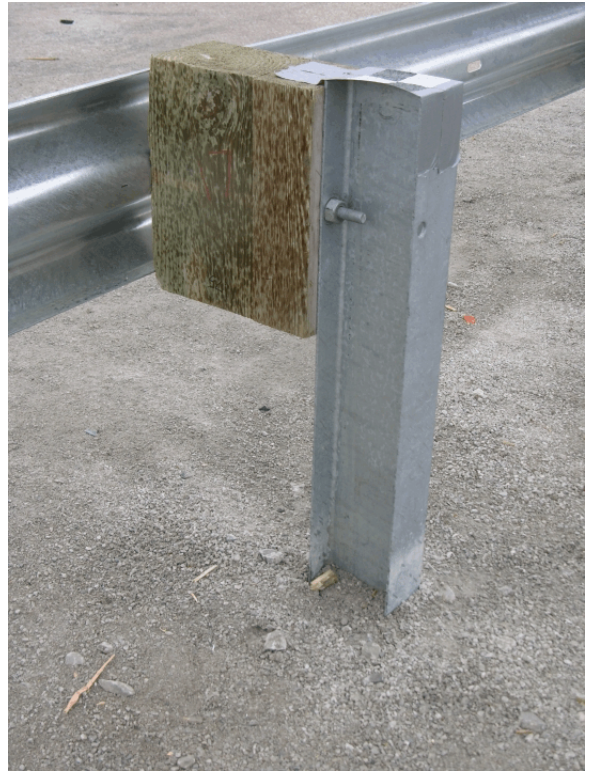
Figure 88. Post Nos. 16 and 17 Damage, Test FR-3

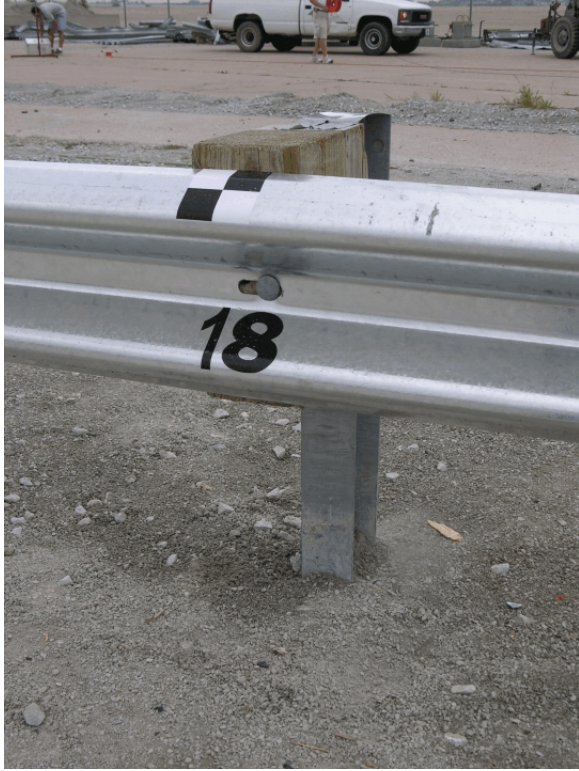
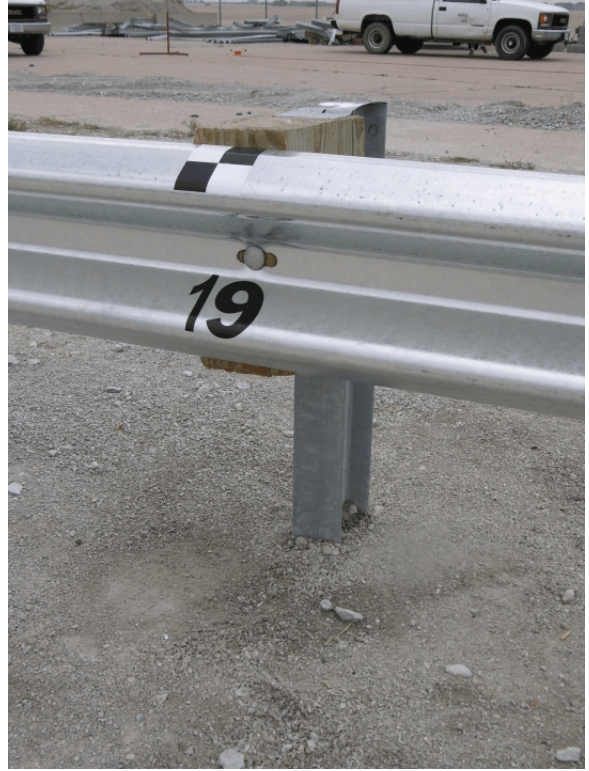
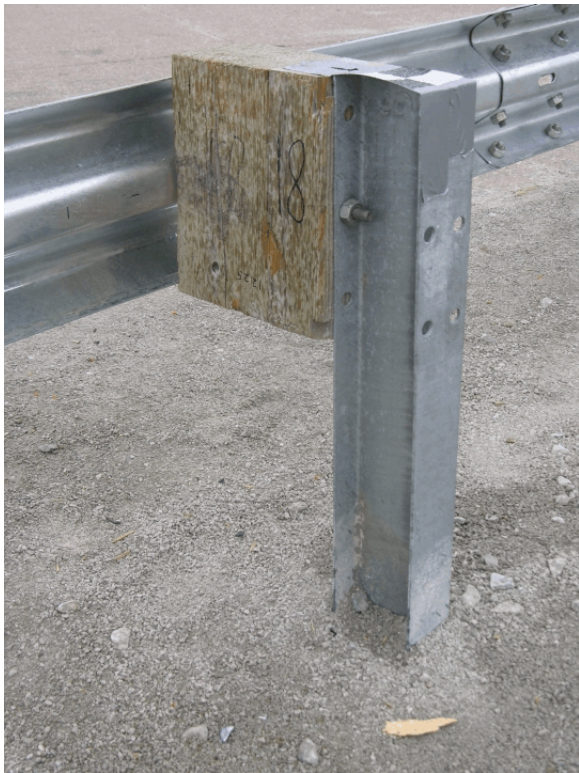
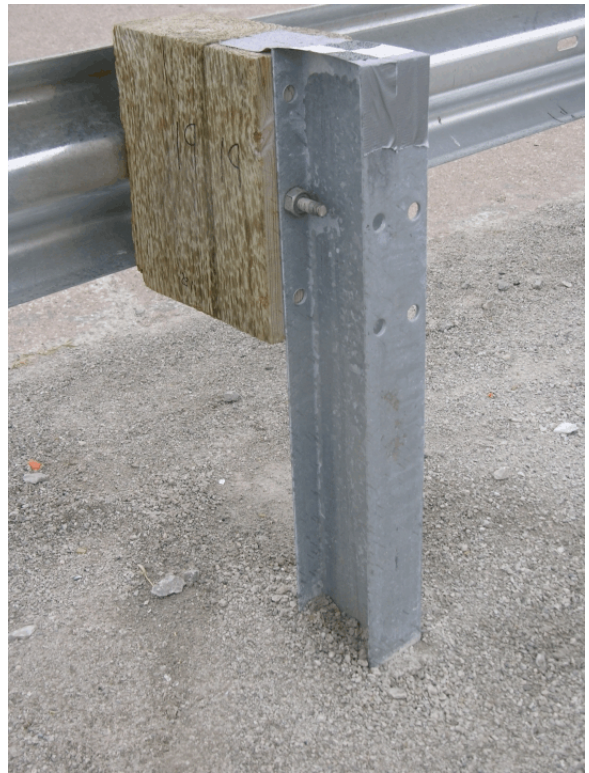
Figure 89. Post Nos. 18 and 19 Damage, Test FR-3

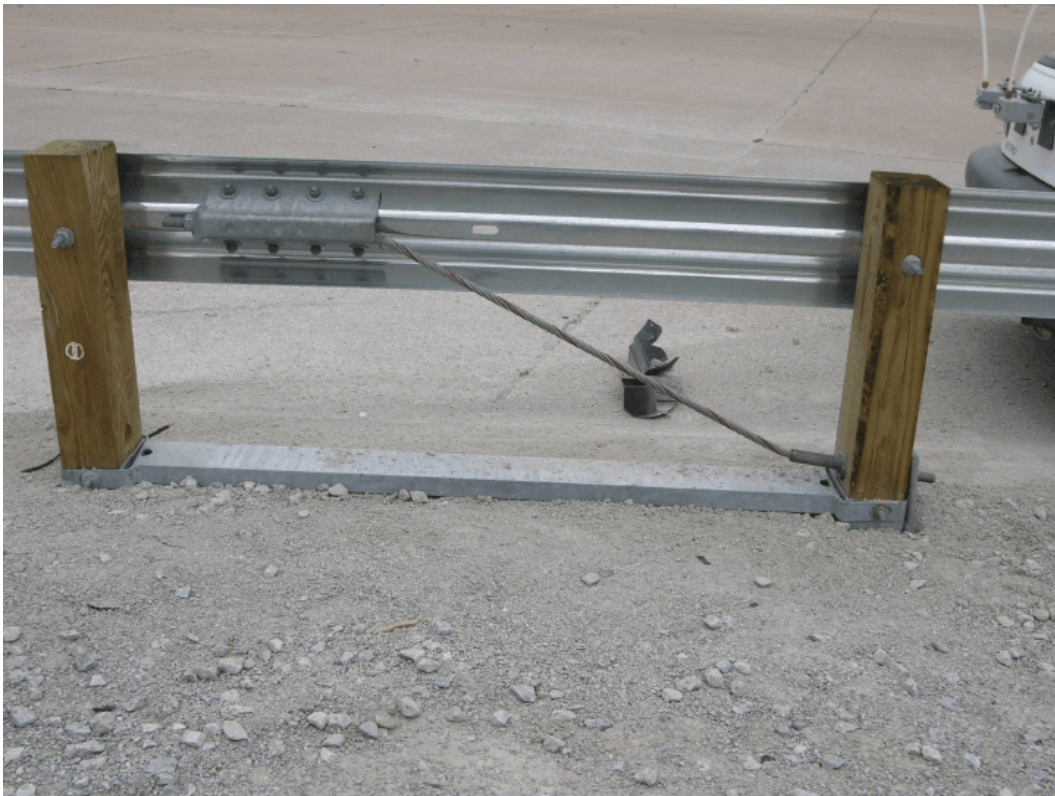
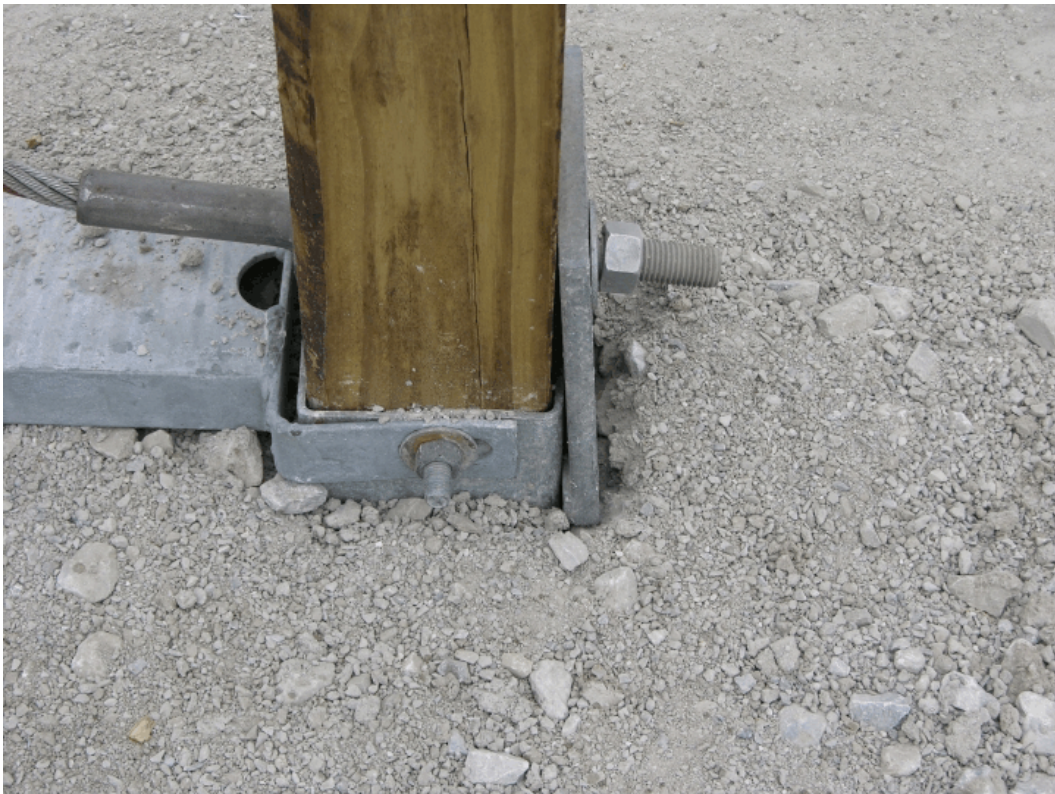
Figure 90. Downstream Anchorage Damage, Test FR-3

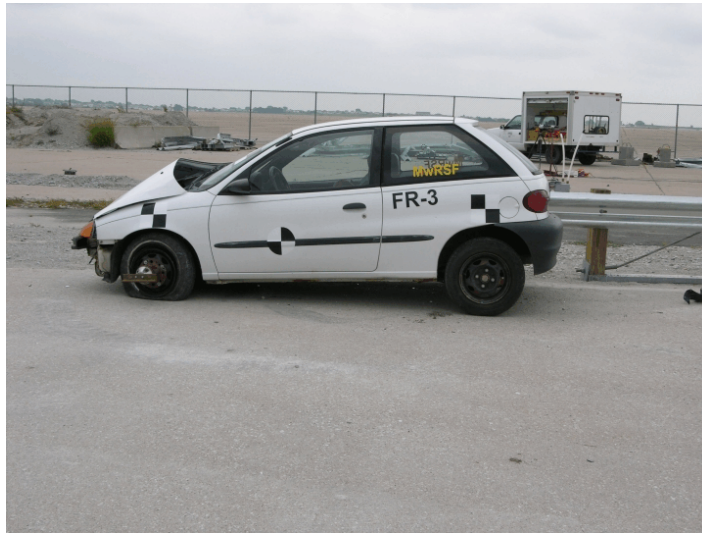
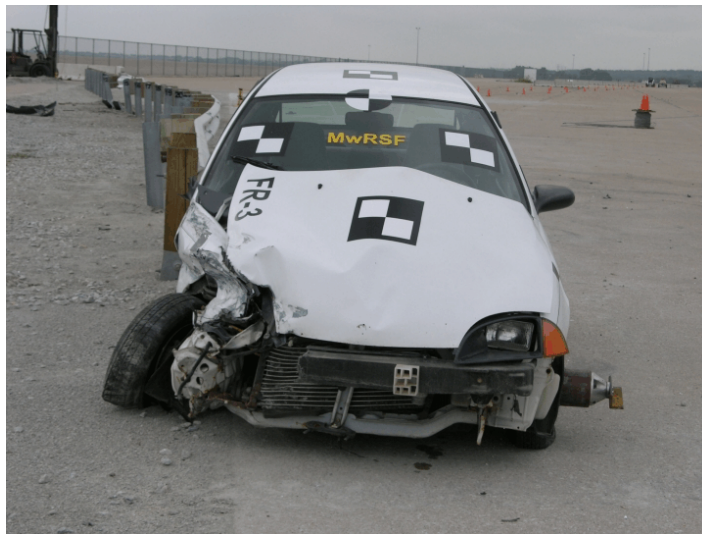
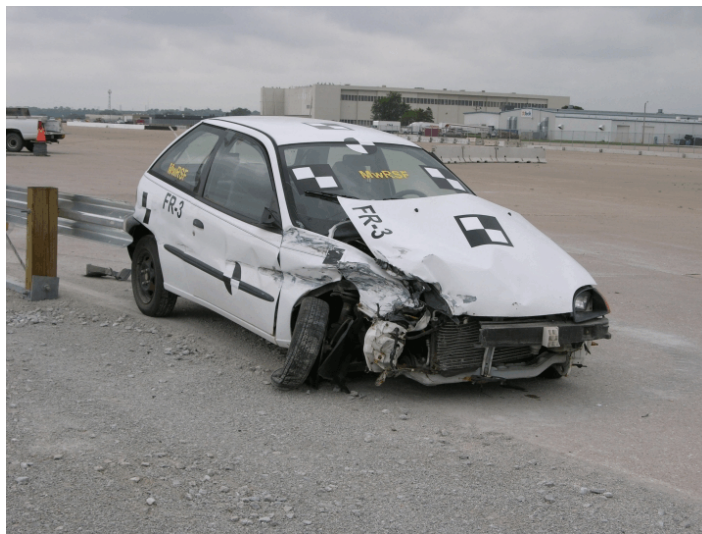
Exterior vehicle damage was moderate, as shown in Figures 91 through 96. Occupant compartment deformations to the right side and center of the floorboard were judged insufficient to cause serious injury to the vehicle occupants. Complete occupant compartment deformations and the corresponding locations are provided in Appendix H.

Figure 91. Vehicle Damage, Test FR-3

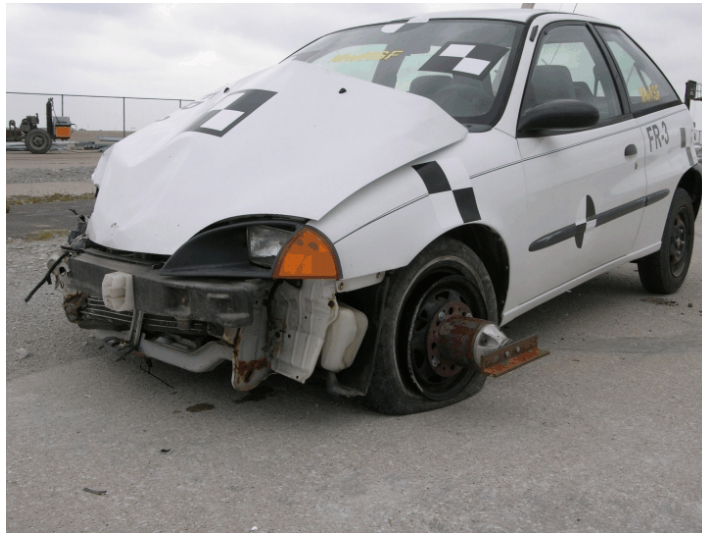
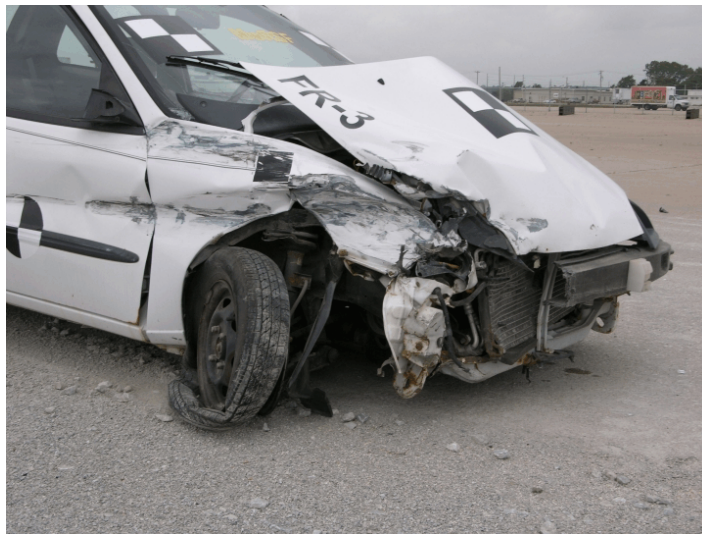
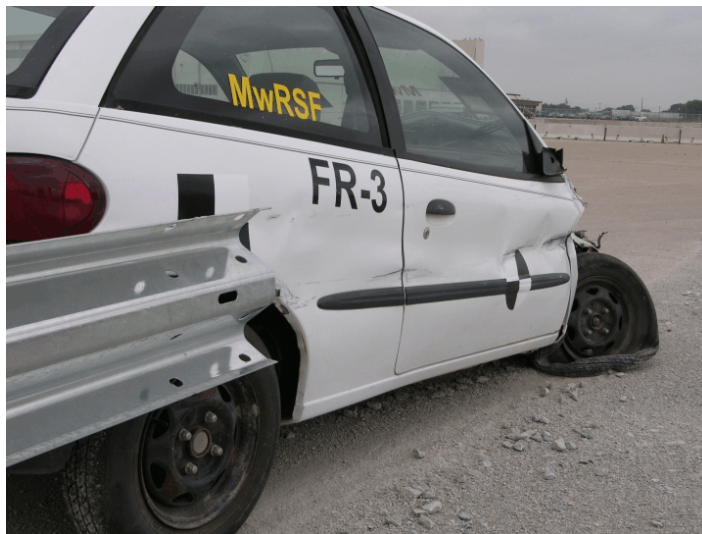
Figure 92. Vehicle Damage, Test FR-3
