# Evaluation of Critical Flare Rates for the Midwest Guardrail System

*Midwest States' Regional Pooled Fund Research Program  
Fiscal Years 2003-2005 (Years 14 and 15)  
Research Project Number SPR-3(017)  
NDOR Sponsoring Agency Code RFPF-04-03 and RFPF-05-05*

# **EVALUATION OF CRITICAL FLARE RATES FOR THE MIDWEST GUARDRAIL SYSTEM (MGS)**

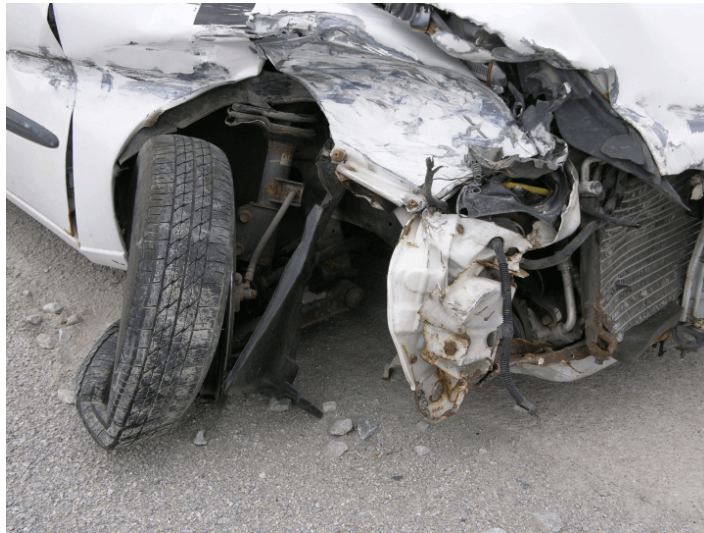
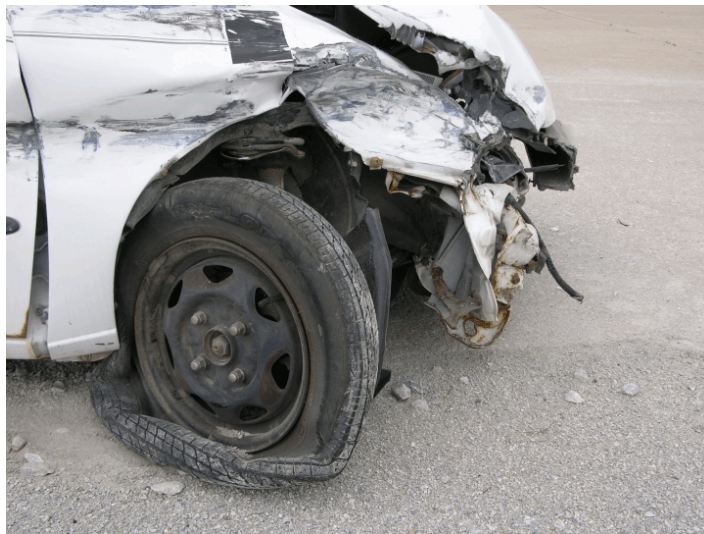
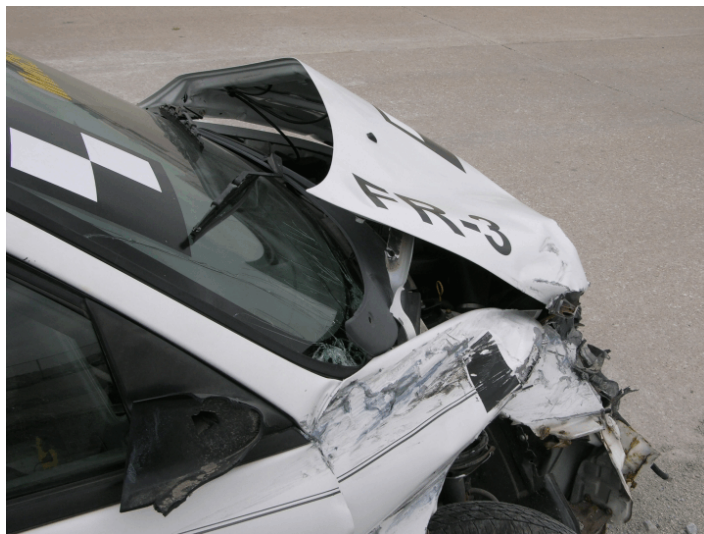
Exterior vehicle damage was moderate, as shown in Figures 91 through 96. Occupant compartment deformations to the right side and center of the floorboard were judged insufficient to cause serious injury to the vehicle occupants. Complete occupant compartment deformations and the corresponding locations are provided in Appendix H.

Figure 93. Vehicle Damage, Test FR-3

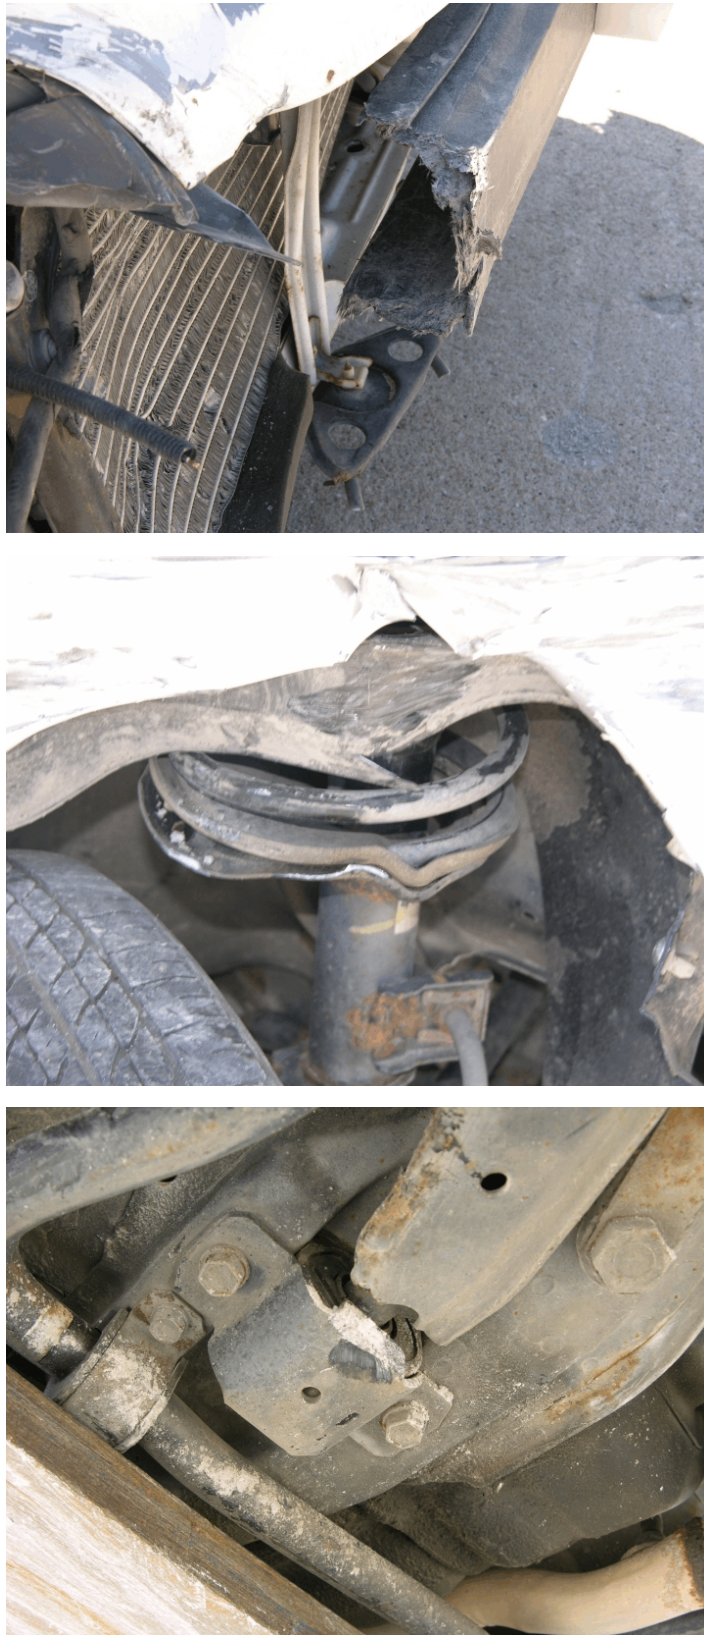
Figure 94. Vehicle Damage, Test FR-3

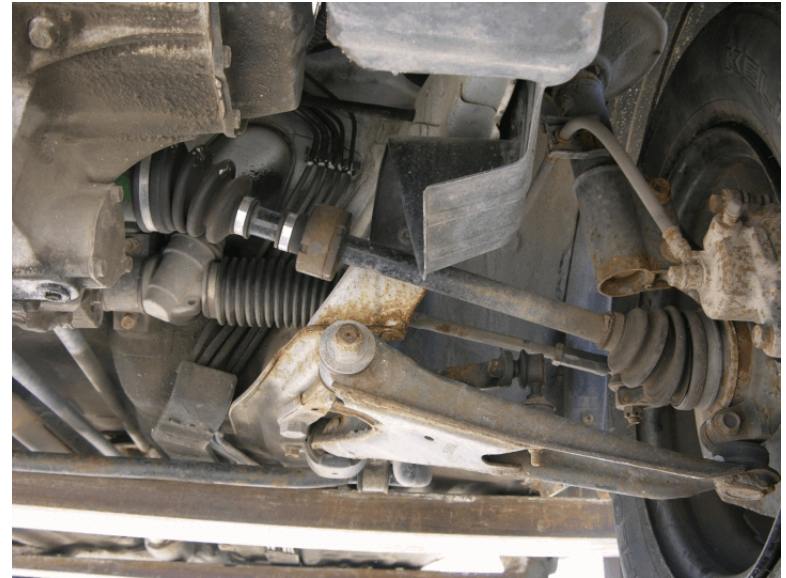
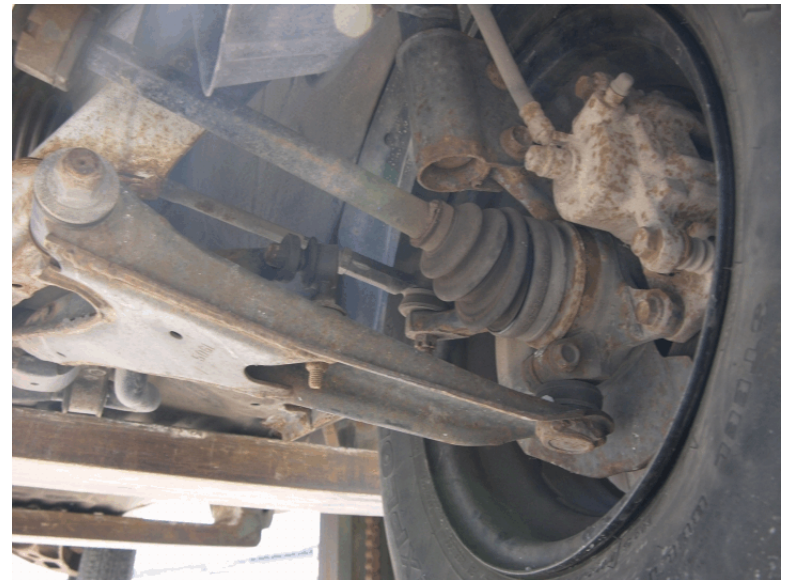
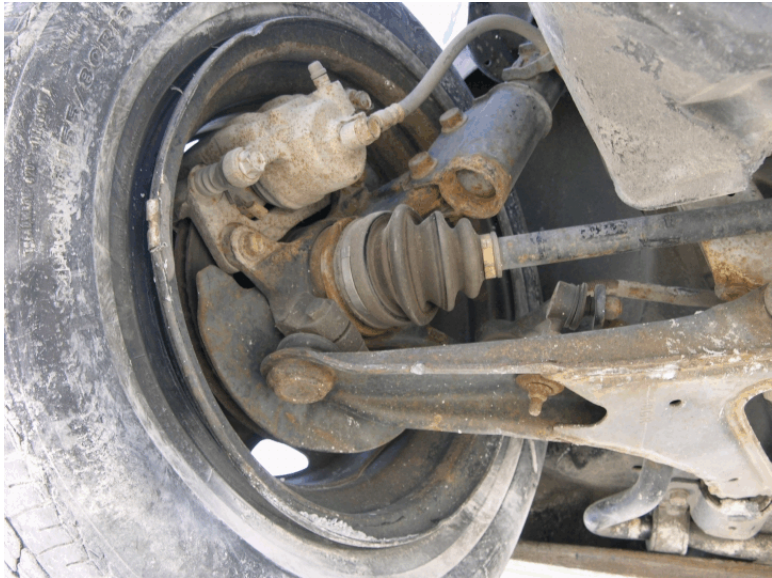
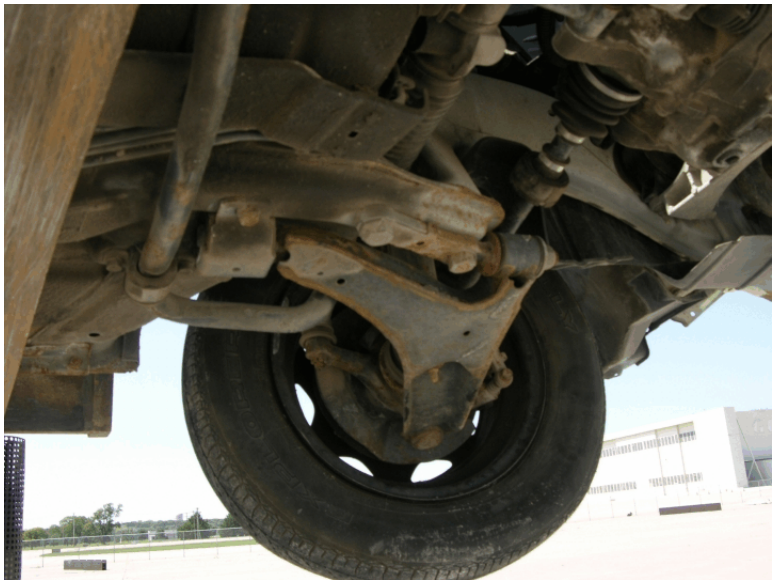
Figure 95. Suspension Damage, Test FR-3

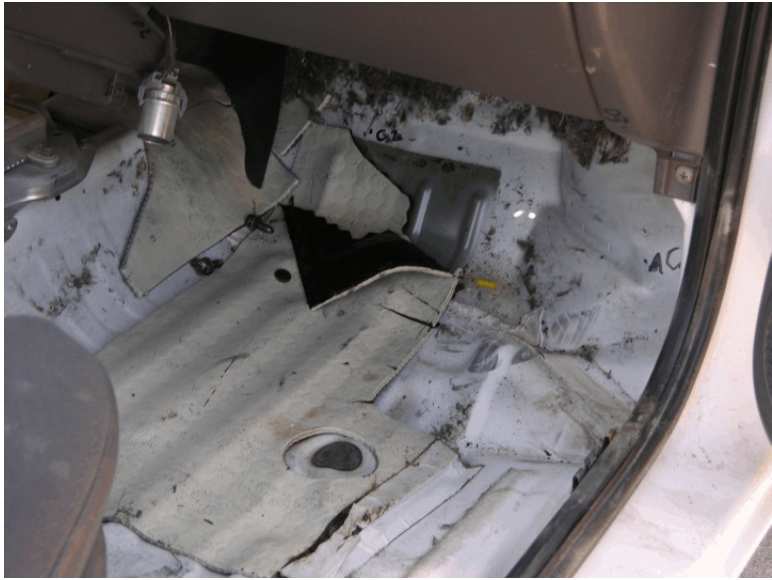
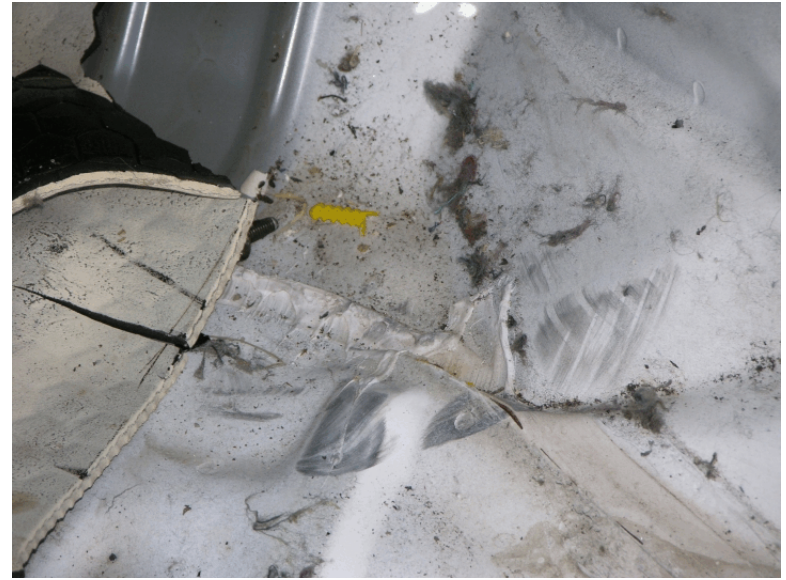
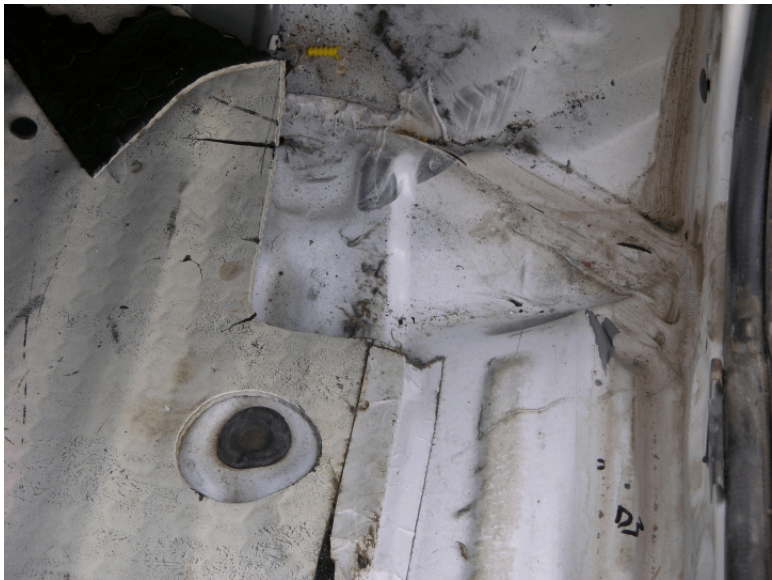
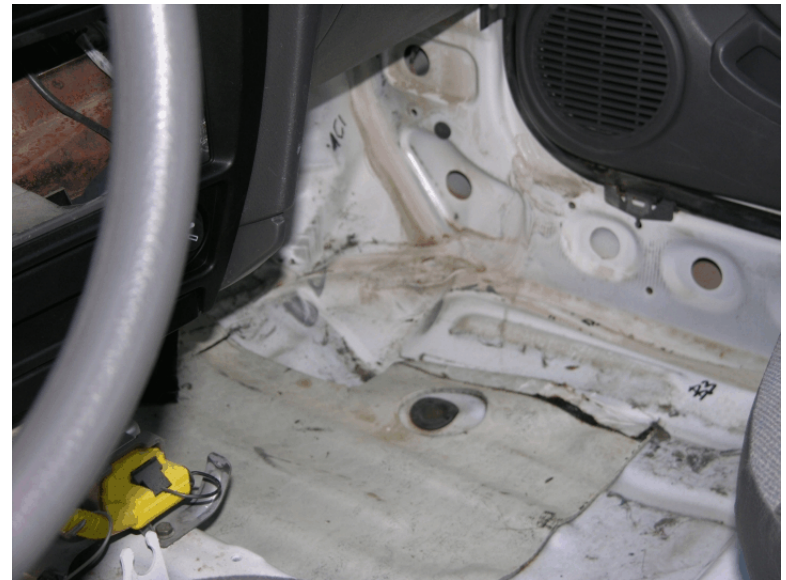
Figure 96. Occupant Compartment Damage, Test FR-3

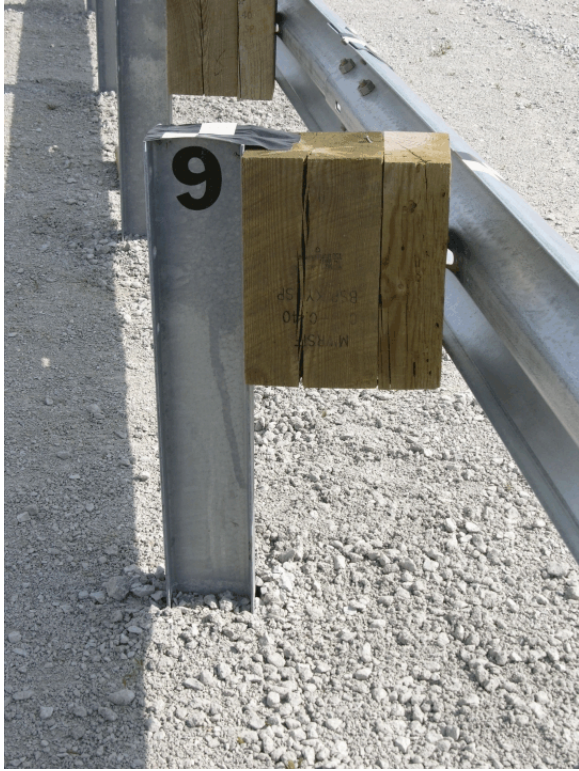
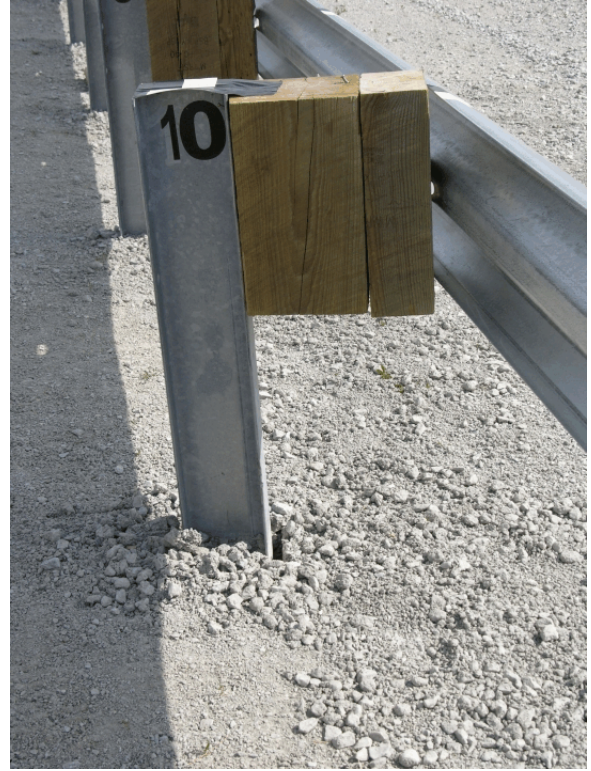
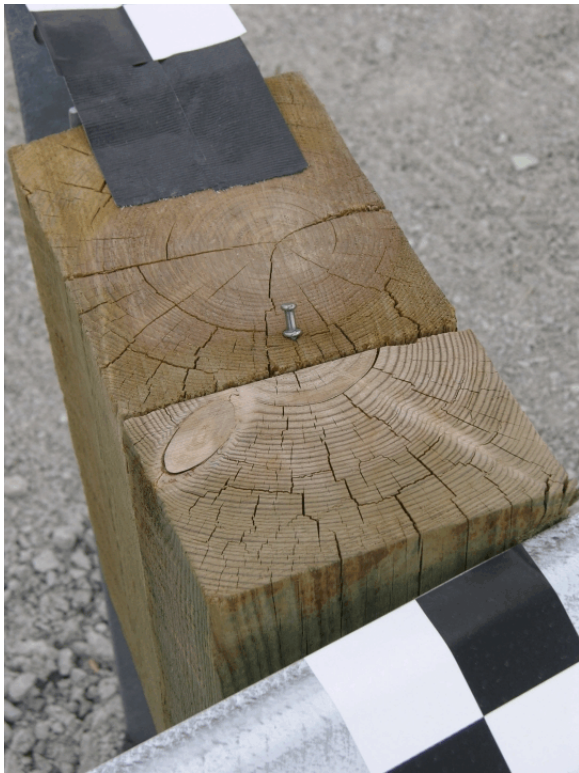
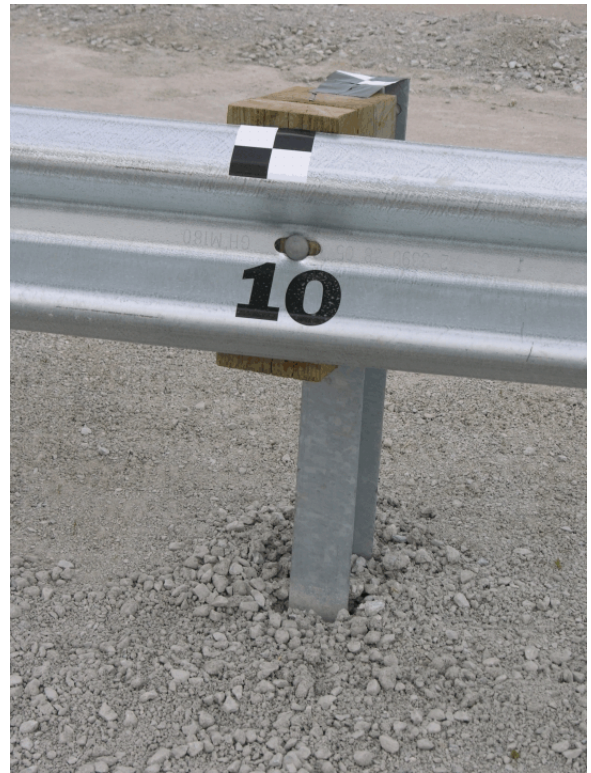
Figure 112. Post Nos. 9 and 10 Damage, Test FR-4

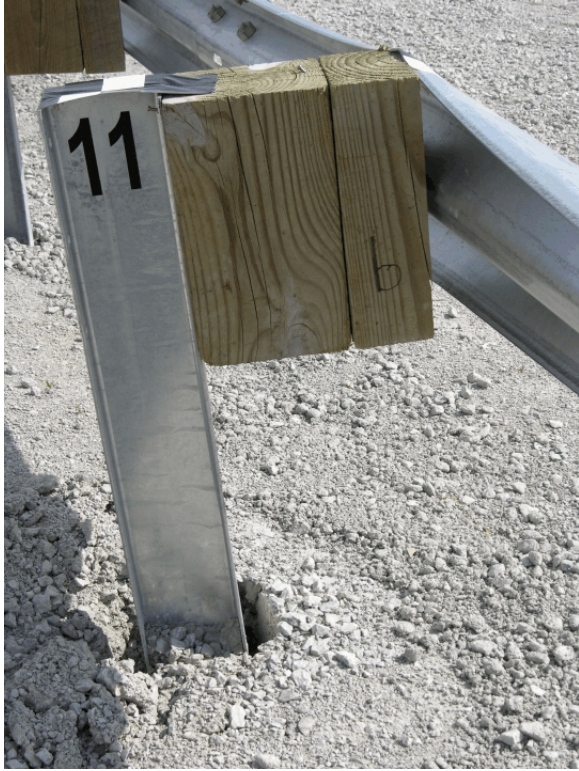
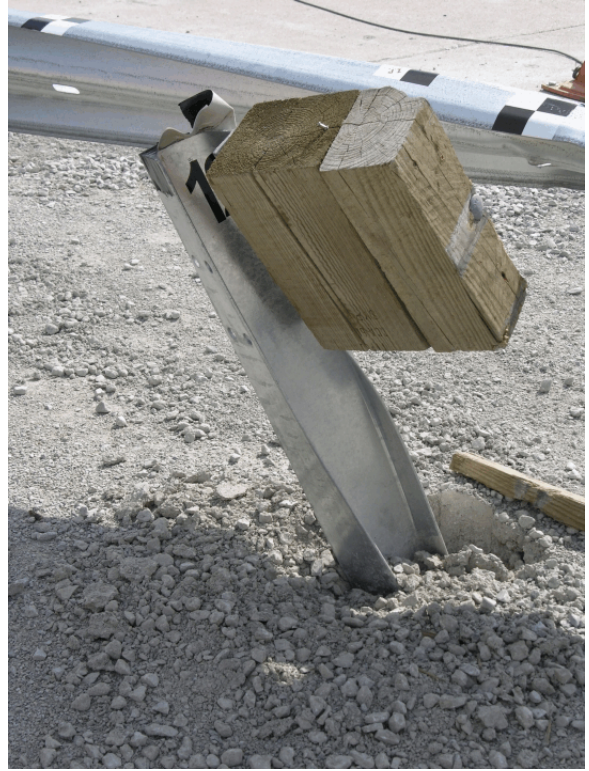
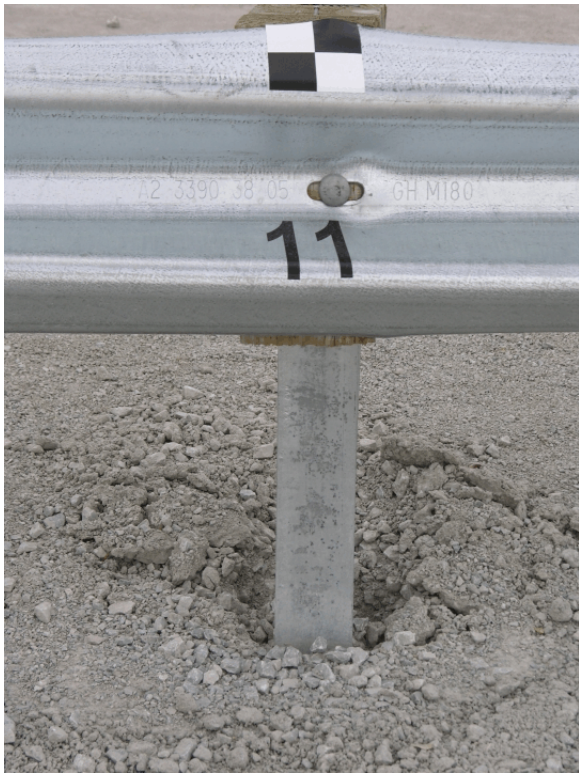
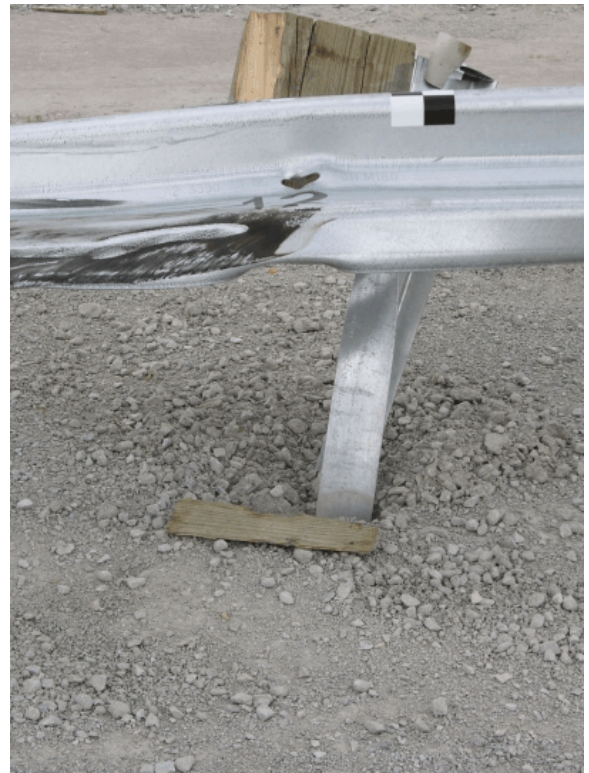
Figure 113. Post Nos. 11 and 12 Damage, Test FR-4

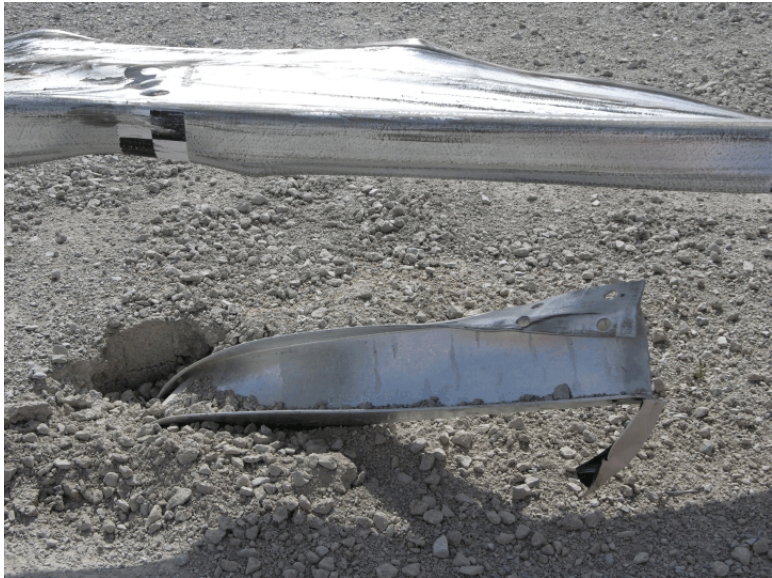
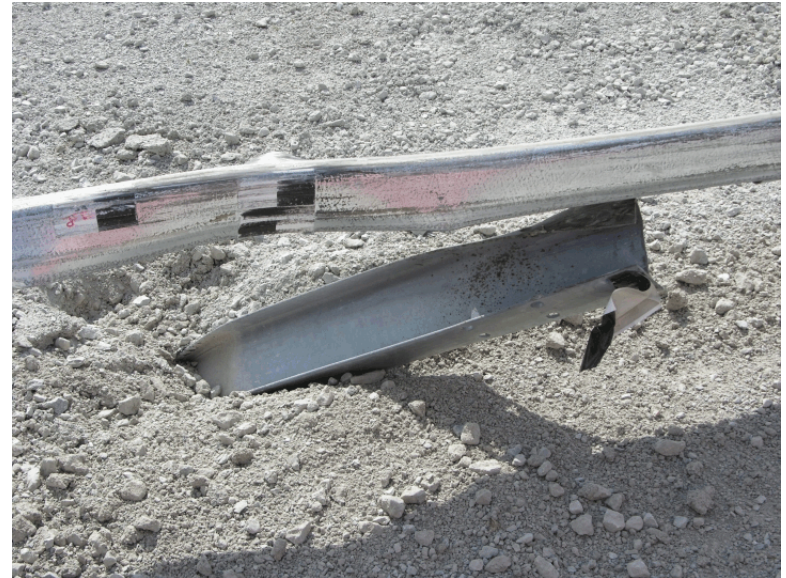
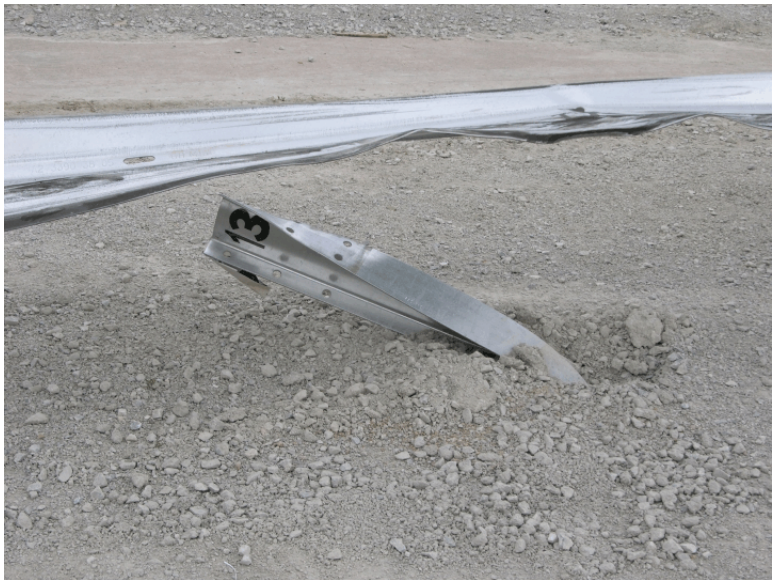
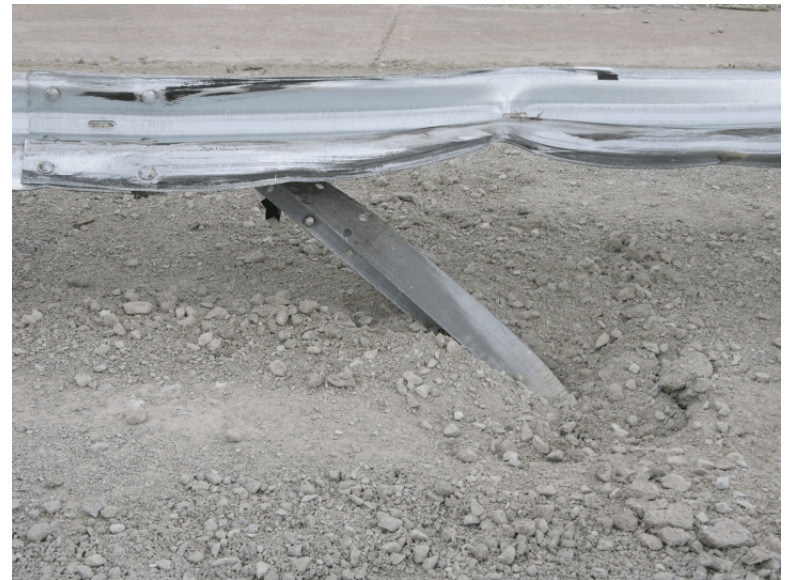
Figure 114. Post Nos. 13 and 14 Damage, Test FR-4

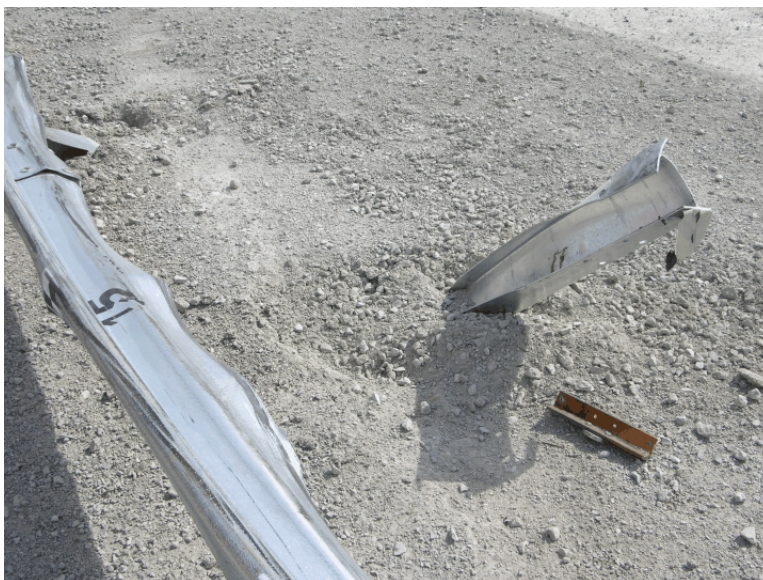
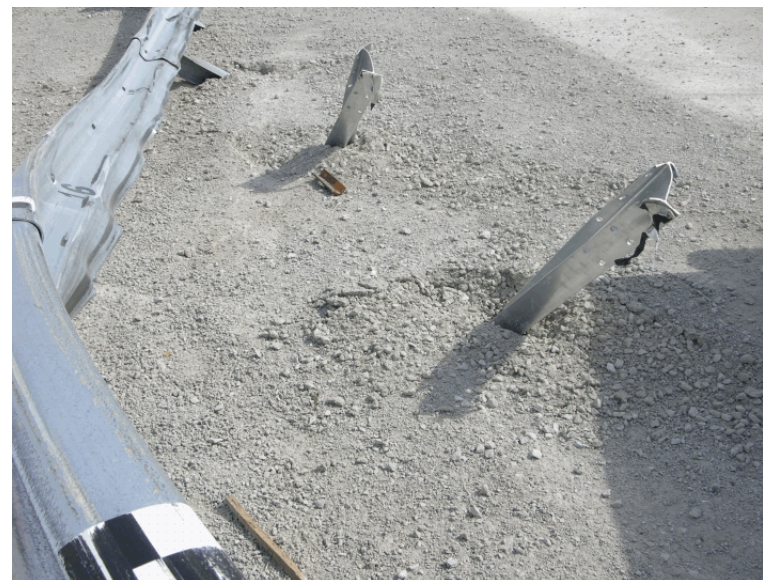
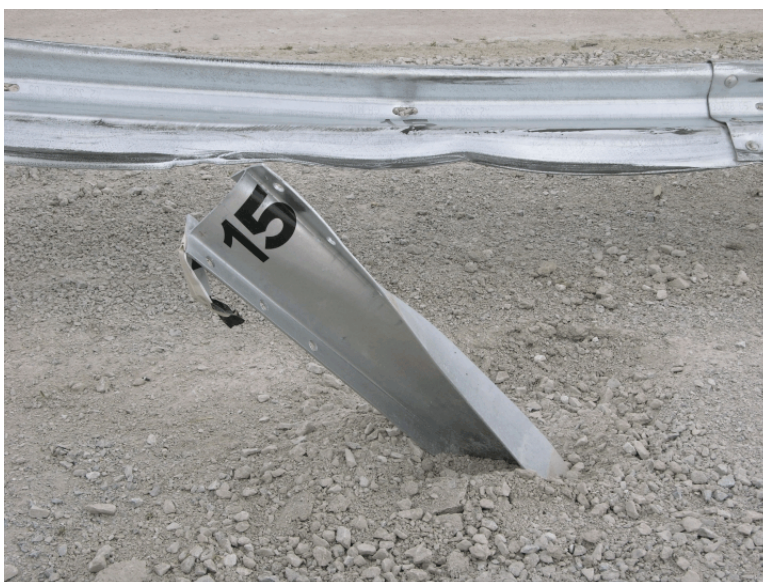
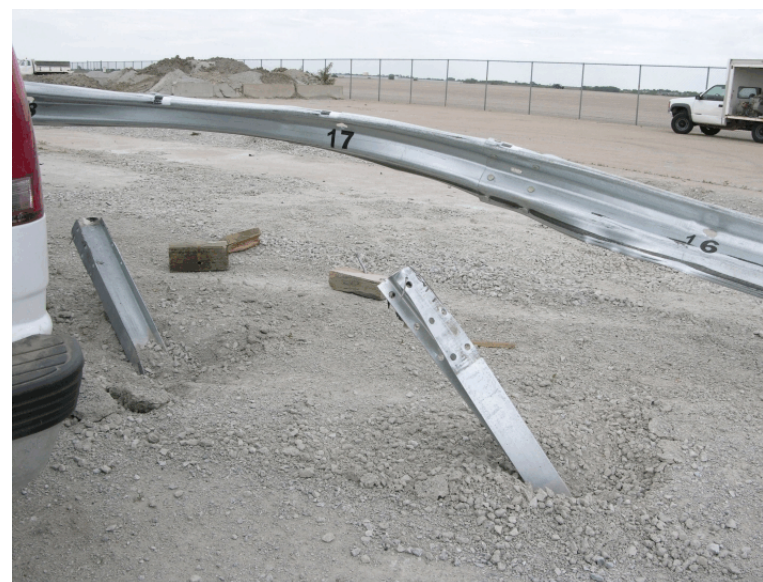
Figure 115. Post Nos. 15 and 16 Damage, Test FR-4

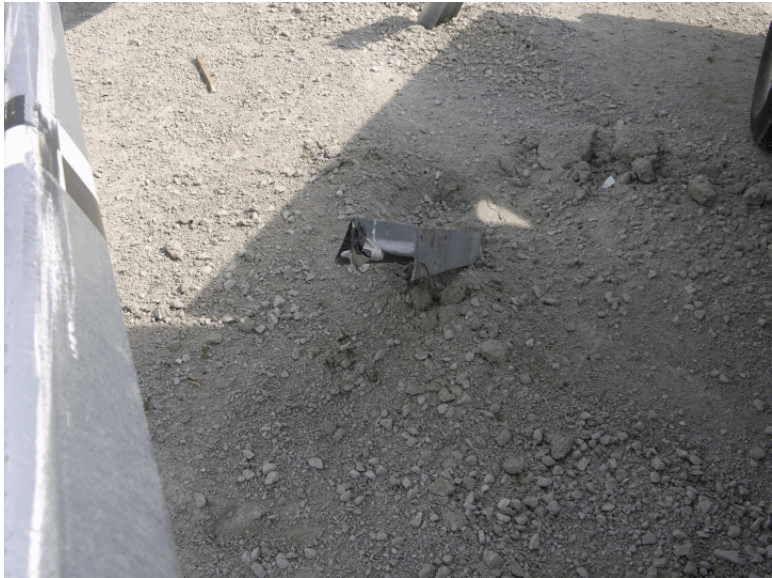
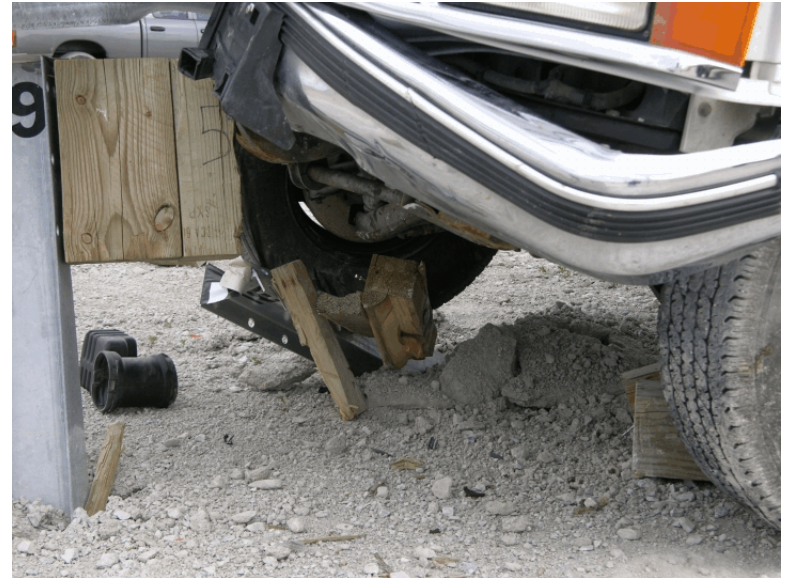
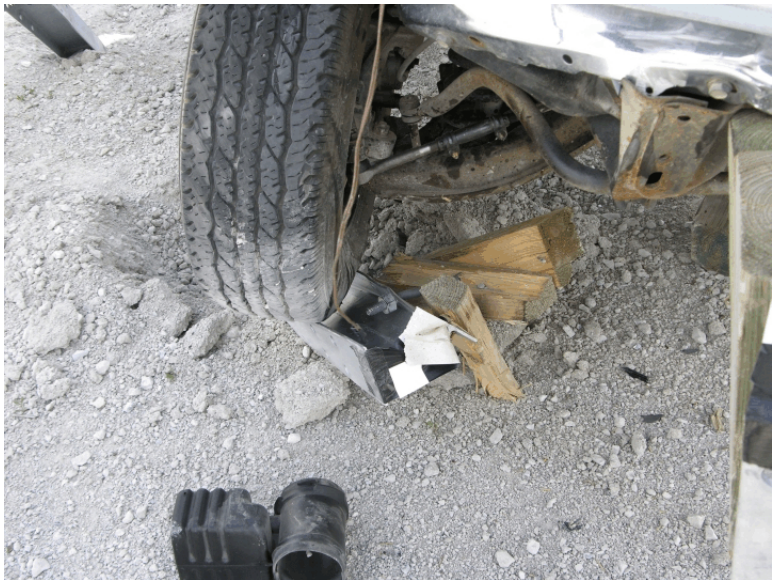
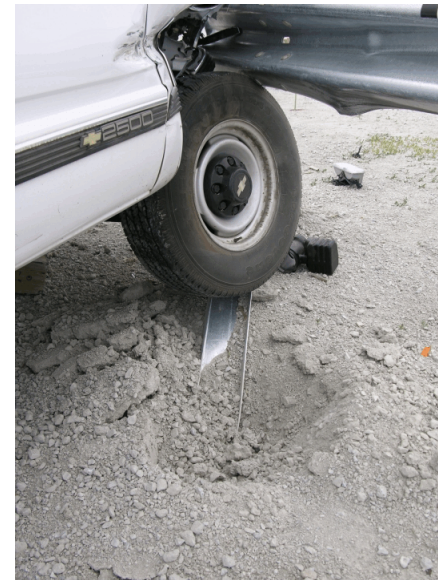
Figure 116. Post Nos. 17 and 18 Damage, Test FR-4

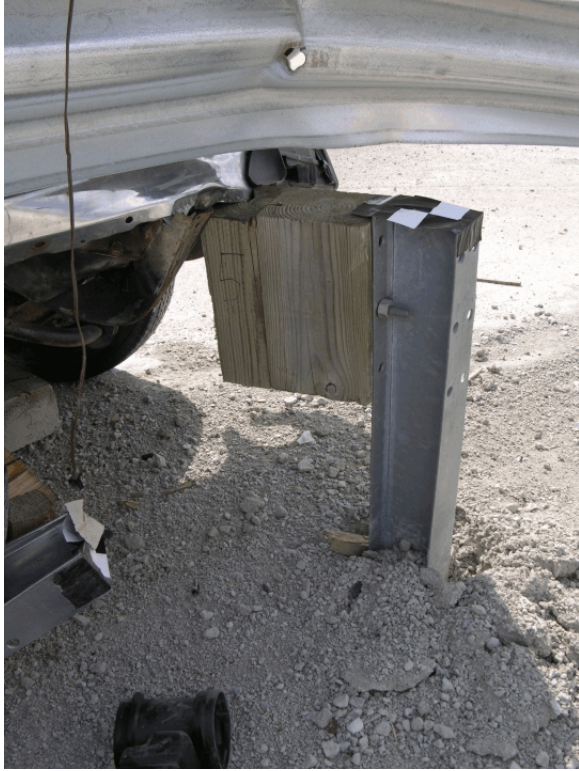
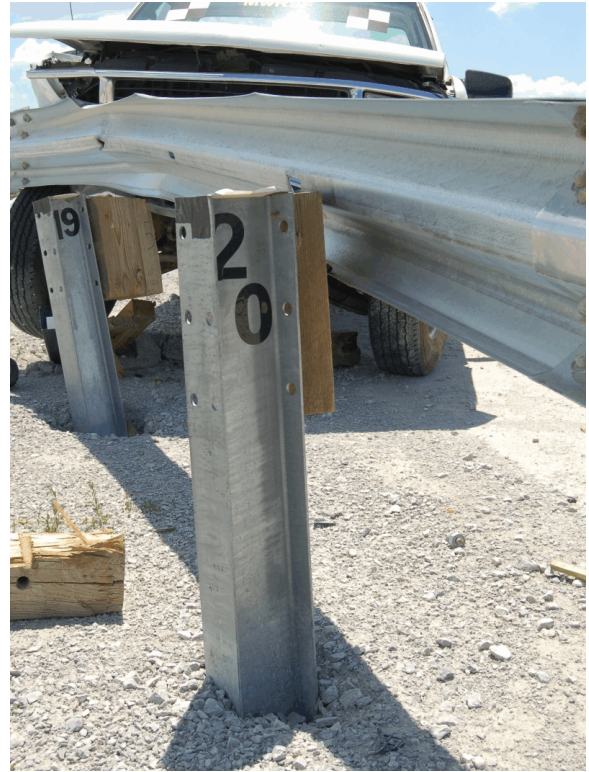
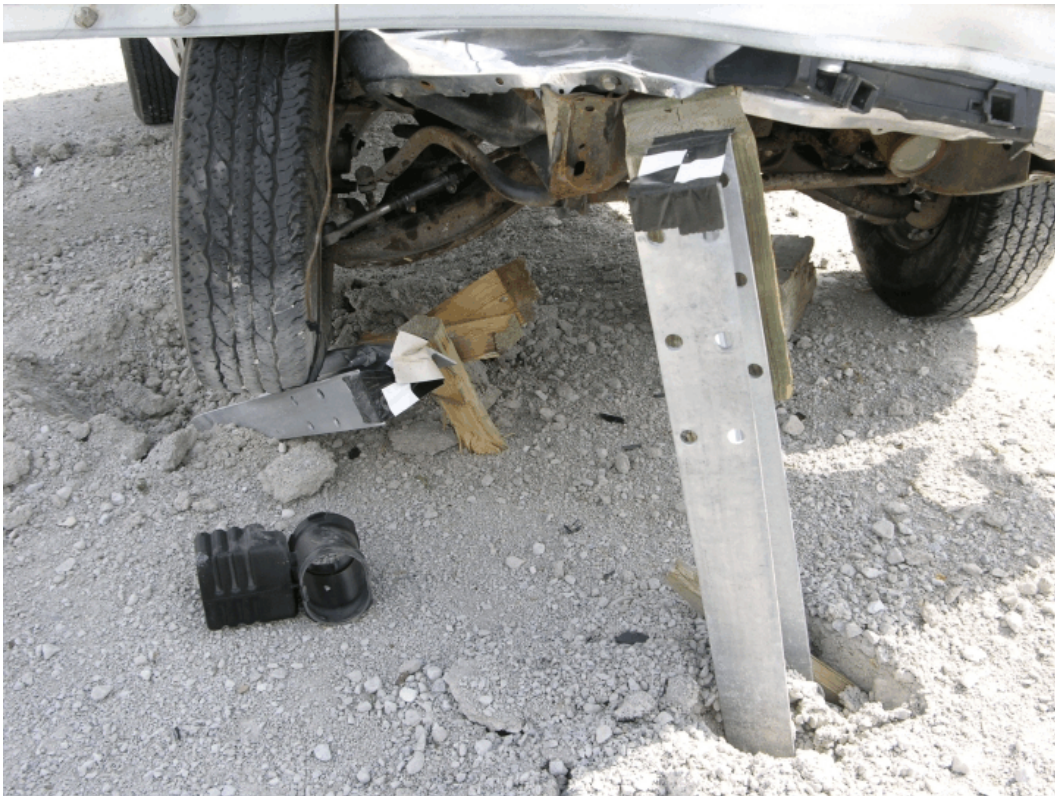
Figure 117. Post Nos. 19 and 20 Damage, Test FR-4

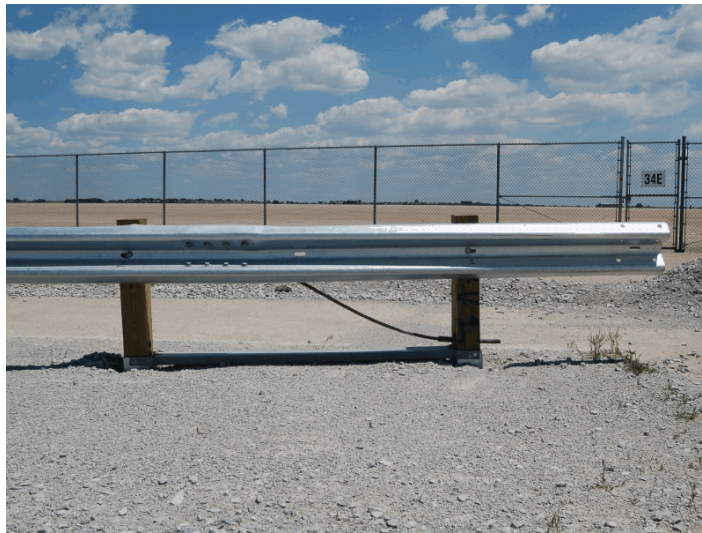
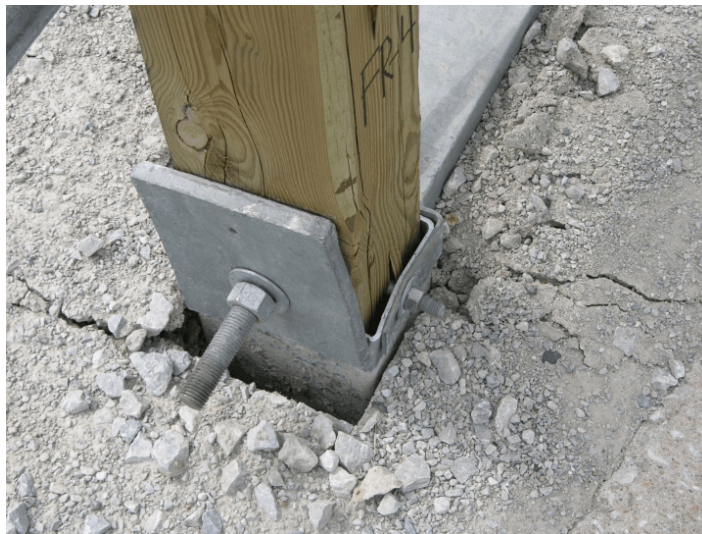
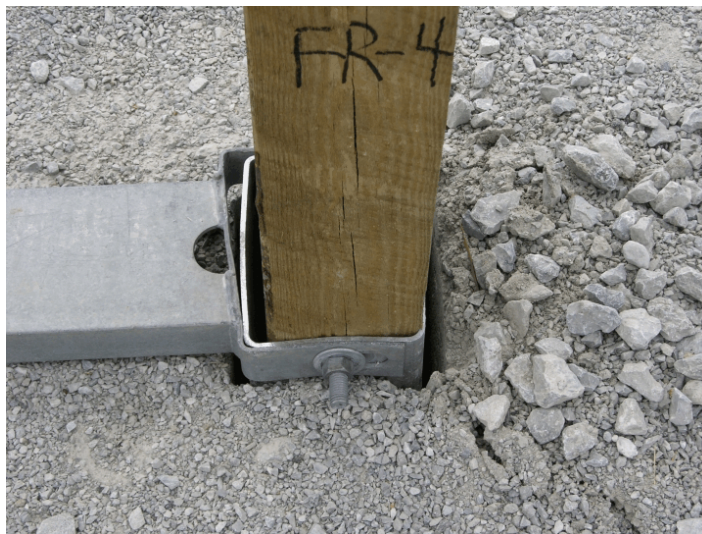
Figure 118. Upstream Anchorage Damage, Test FR-4

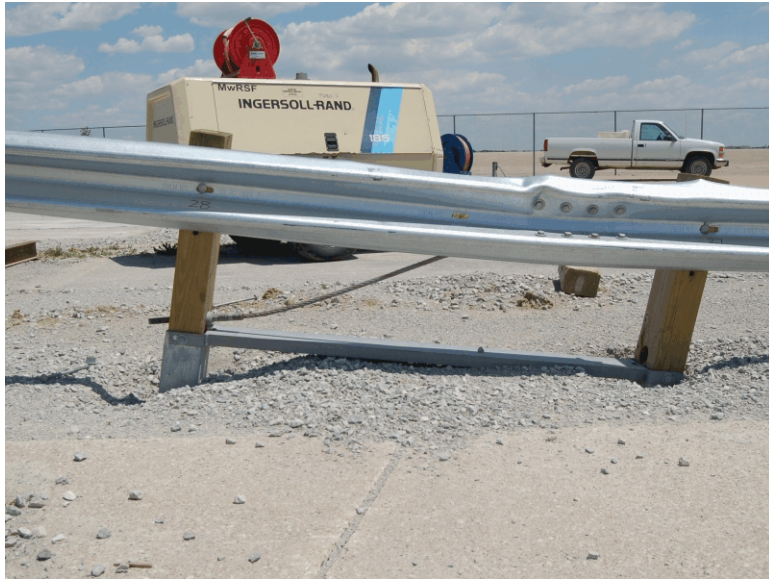
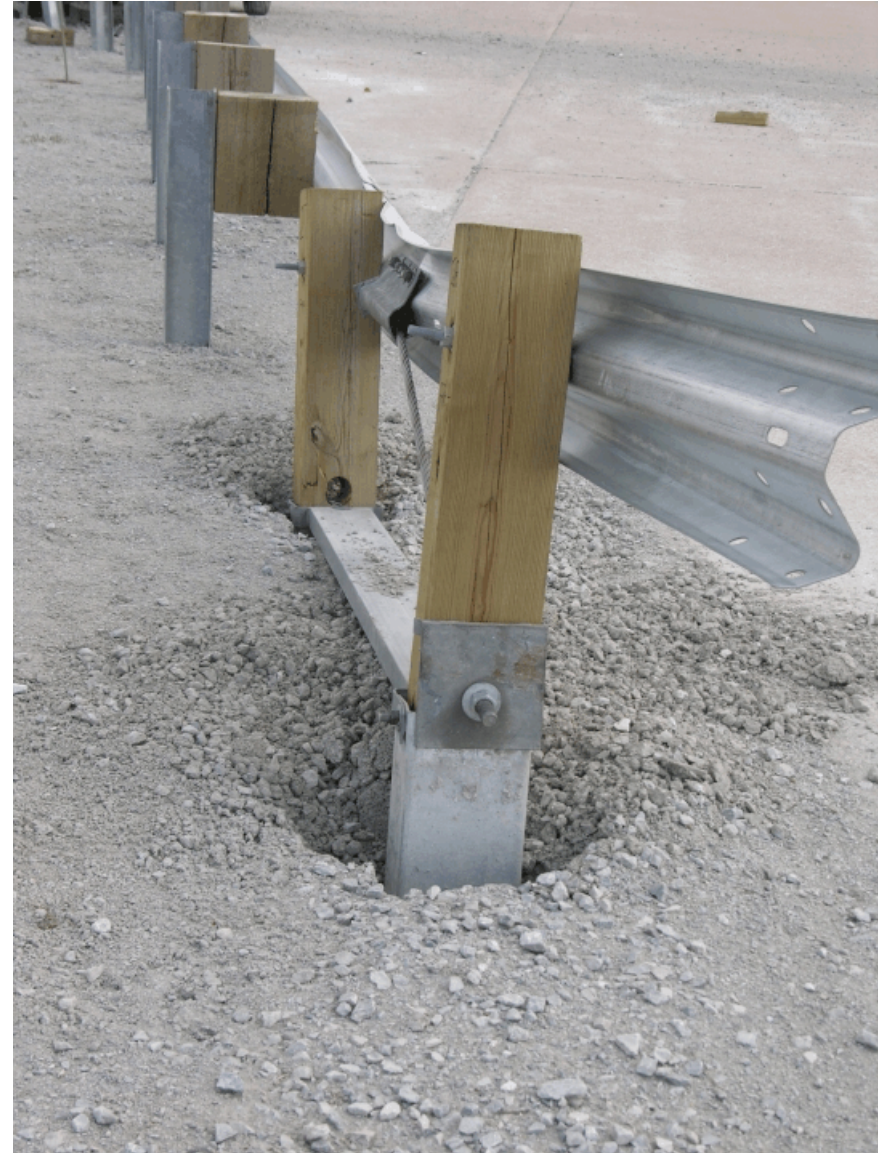
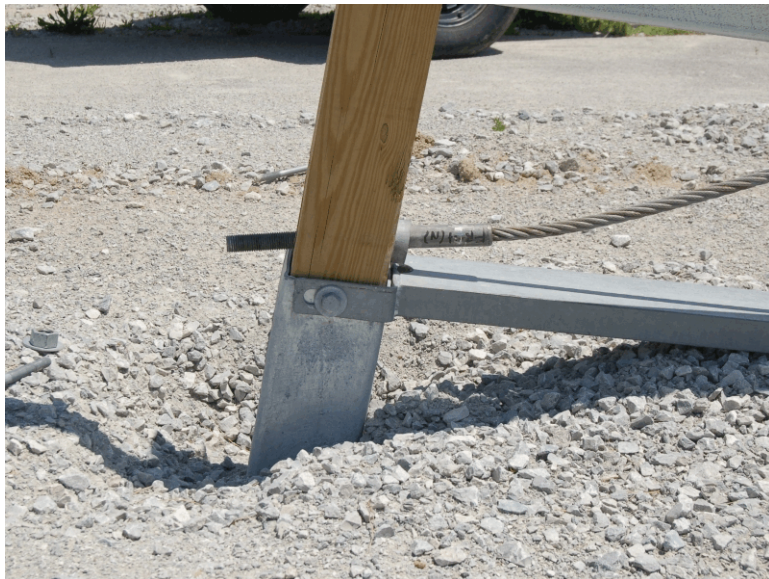
Figure 119. Downstream Anchorage Damage, Test FR-4

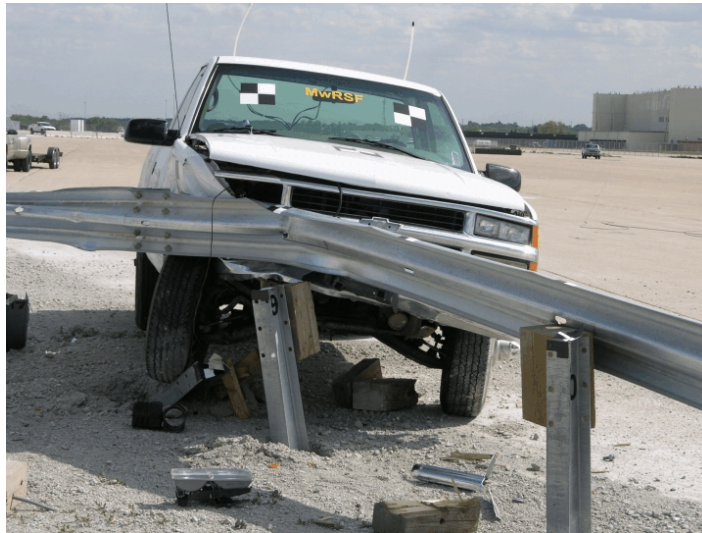
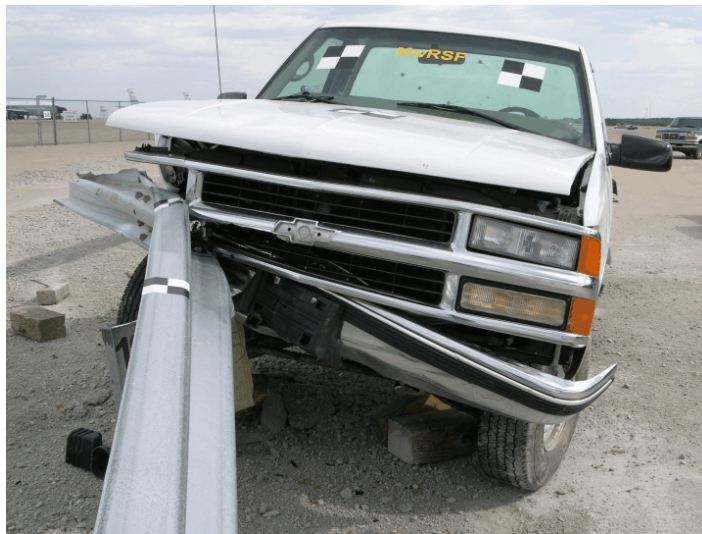
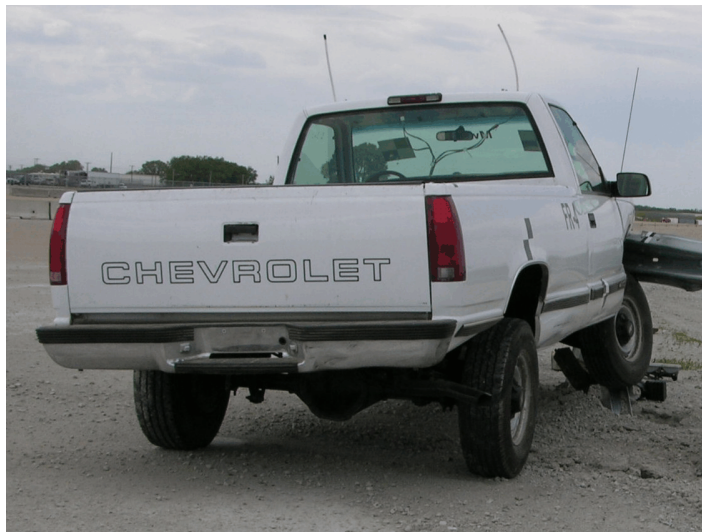
Exterior vehicle damage was moderate, as shown in Figures 120 through 122. Occupant compartment deformations to the right side and center of the floorboard were judged insufficient to cause serious injury to the vehicle occupants. Maximum longitudinal deflections of 6 mm (0.25 in.)

Figure 120. Vehicle Damage, Test FR-4

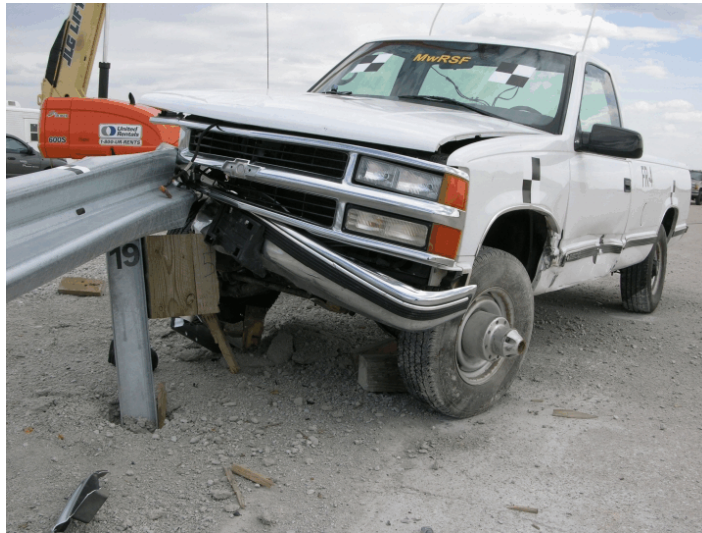
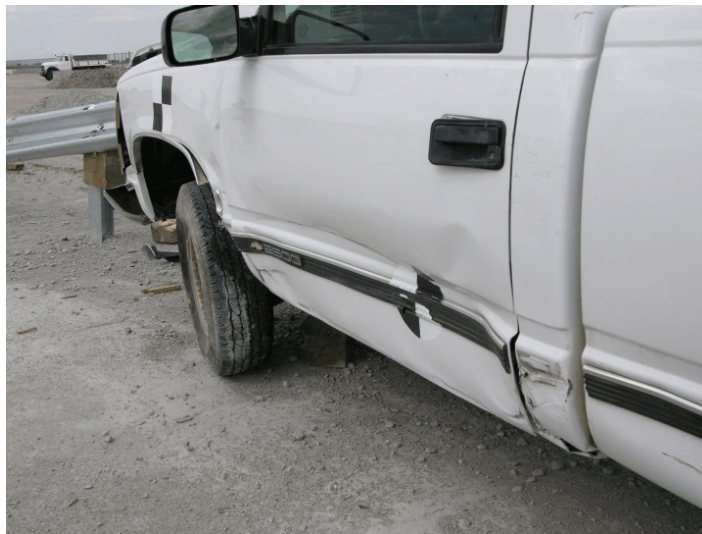
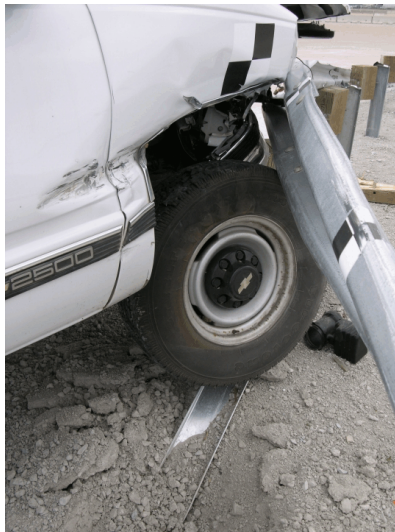
Figure 121. Vehicle Damage, Test FR-4
