# Evaluation of Critical Flare Rates for the Midwest Guardrail System

*Midwest States' Regional Pooled Fund Research Program  
Fiscal Years 2003-2005 (Years 14 and 15)  
Research Project Number SPR-3(017)  
NDOR Sponsoring Agency Code RFPF-04-03 and RFPF-05-05*

# **EVALUATION OF CRITICAL FLARE RATES FOR THE MIDWEST GUARDRAIL SYSTEM (MGS)**

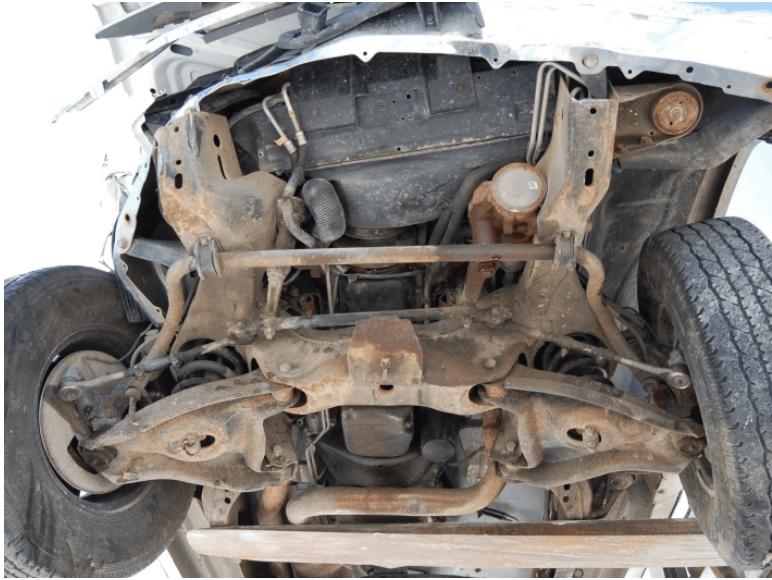
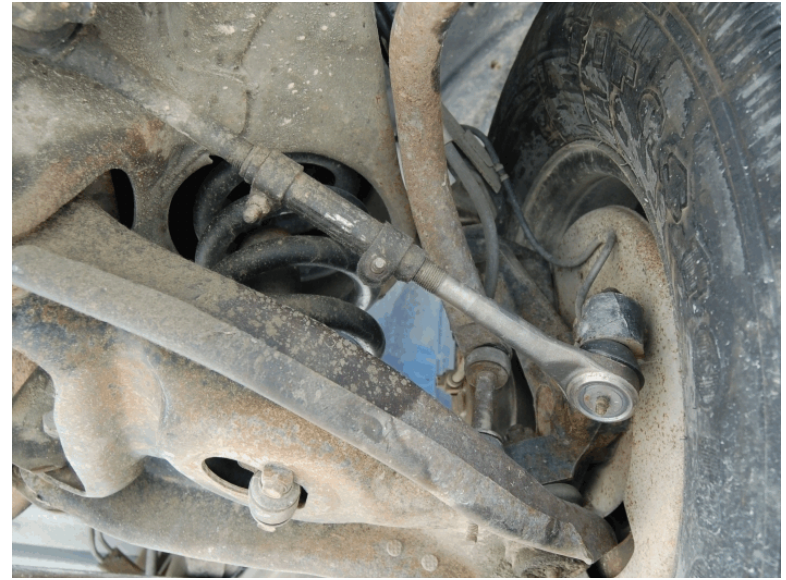
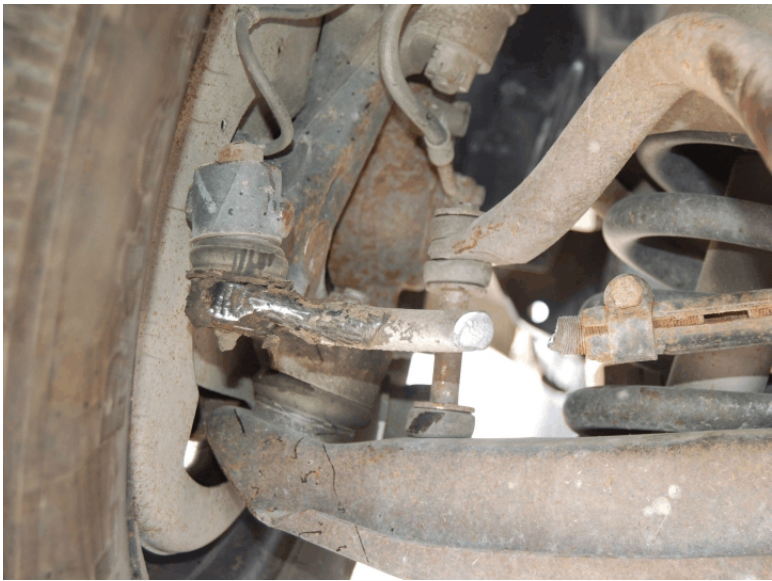
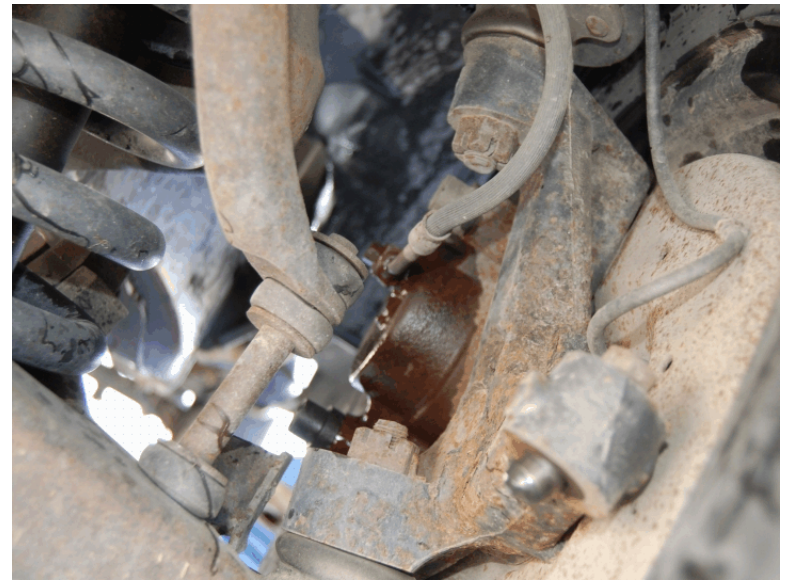
Exterior vehicle damage was moderate, as shown in Figures 120 through 122. Occupant compartment deformations to the right side and center of the floorboard were judged insufficient to cause serious injury to the vehicle occupants. Maximum longitudinal deflections of 6 mm (0.25 in.)

Figure 122. Undercarriage Damage, Test FR-4

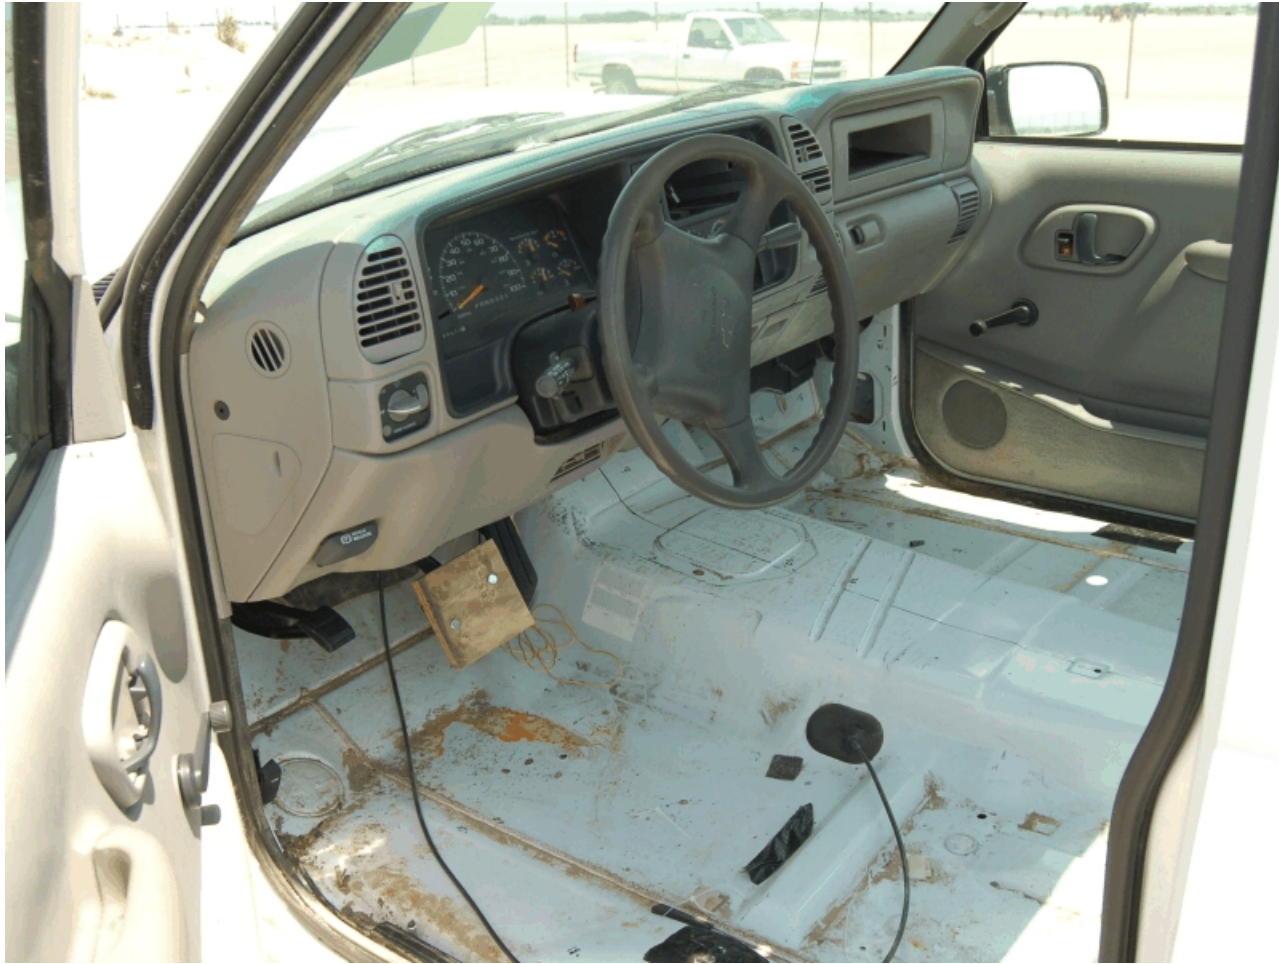
were located along the center and right side of the right-side floorpan. Maximum lateral deflections of 19 mm (0.75 in.) were located along the firewall and near the left center of the right-side floorpan. Maximum vertical deflections of 13 mm (0.5 in.) were located near the left-rear corner of the right-side floorpan. The occupant compartment deformation is shown in Figure 123. Complete occupant compartment deformations and the corresponding locations are provided in Appendix K.

Figure 123. Occupant Compartment Deformation, Test FR-4

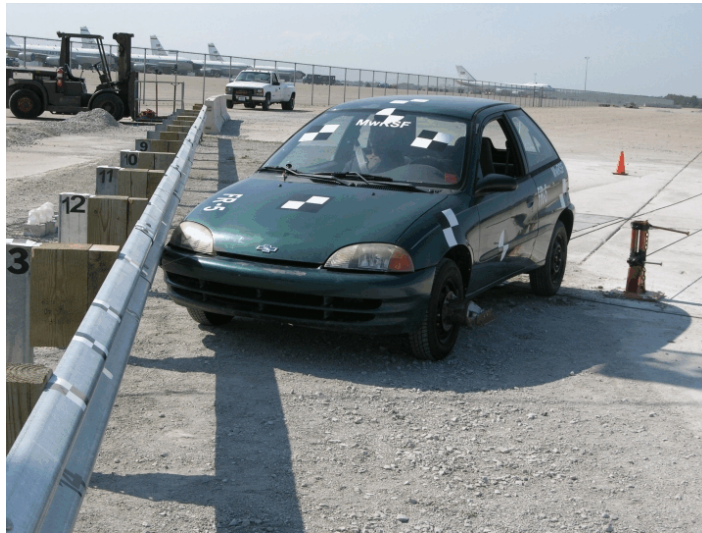
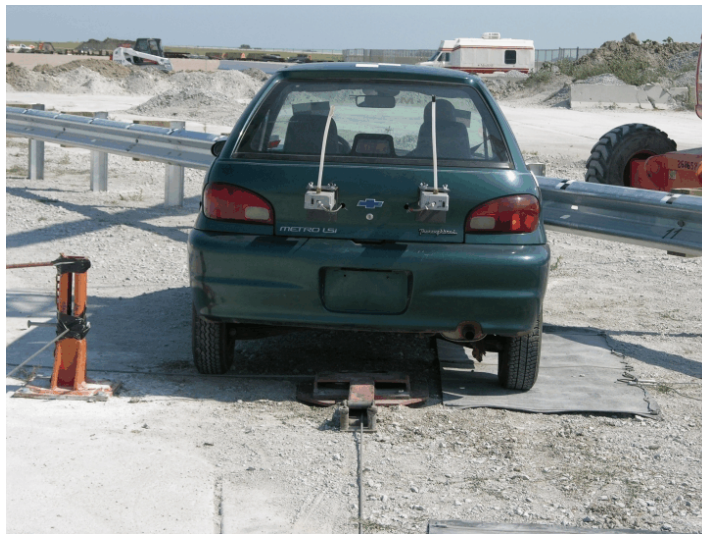
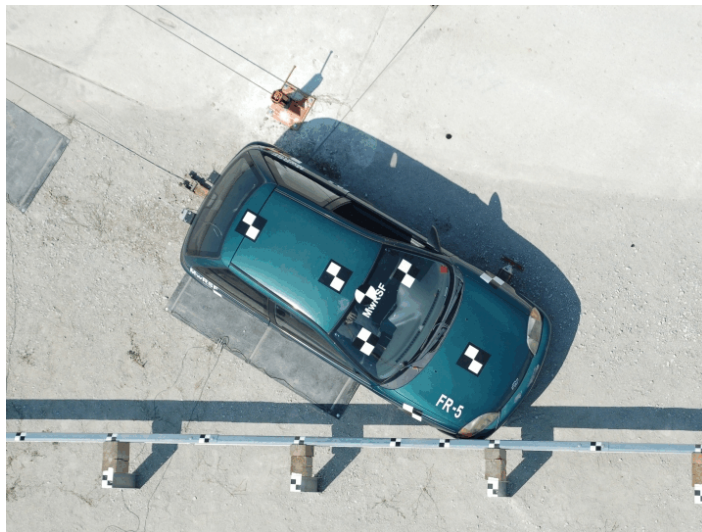
Figure 130. Impact Location, Test FR-5

Initial impact was to occur between post nos. 11 and 12, or 1.43 m (4 ft - 8.25 in.) upstream from the centerline of the splice between post nos. 12 and 13, as shown in Figure 130. Actual vehicle impact occurred 1.38 m (4 ft - 6.25 in.) upstream from the centerline of the splice between post nos. 12 and 13. Immediately after impact, the bumper deformed, and the rail deflected backwards. At 0.008 sec, post no. 12 deflected backwards, and the front of the hood jarred open. At 0.014 sec, the rail deformed and flattened, and post no. 11 deflected. At 0.024 sec, the bumper cover protruded under the rail, and post no. 13 deflected. At 0.038 sec, the right-front corner of the bumper protruded under the rail. At this same time, post no. 14 deflected backwards. At 0.062 sec, the bumper, right-front quarter panel, and hood deformed, and the midpoint of the grill deformed and cracked. At 0.074 sec, the guardrail buckled both upstream and downstream of post no. 14, and the bumper contacted the edge of the upstream flange of post no. 13 and disengaged from the right-side mounting clips. At 0.096 sec, post no. 15 deflected. At 0.108 sec, the blockout at post no. 13 fractured. At 0.114 sec, the right-front tire contacted post no. 13. At 0.132 sec, the right-front tire

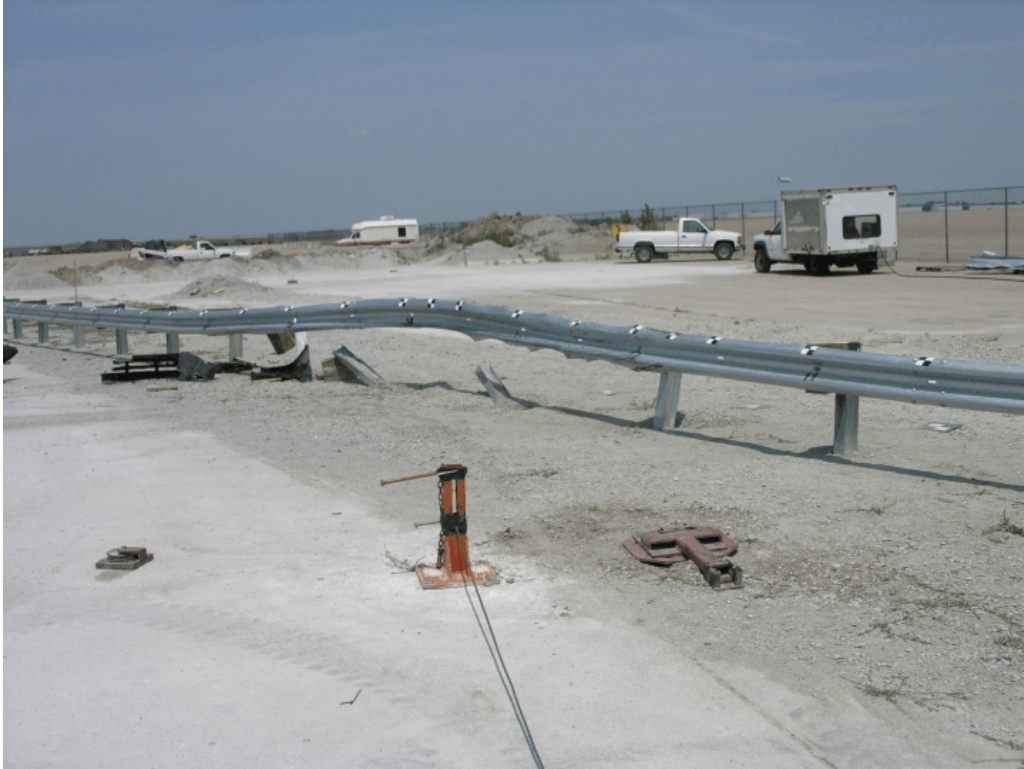
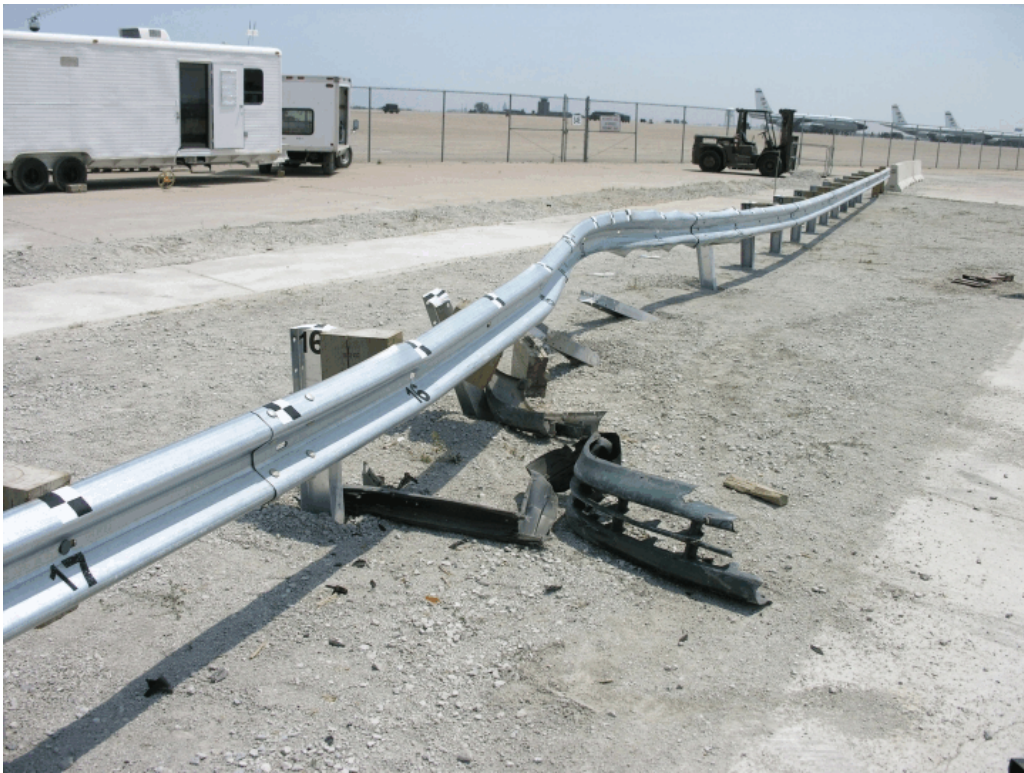
Figure 132. System Damage, Test FR-5

Damage to the barrier system was minimal, as shown in Figures 132 through 140. Barrier damage consisted of deformed guardrail posts, deformed and disengaged blockouts, deformed guardrail, and contact marks on a guardrail section. The length of vehicle contact along the system was approximately 6.14 m (20 ft - 4.75 in.), which spanned from 425 mm (16.75 in.) upstream from the centerline of post no. 12 through the centerline of post no. 15.

The permanent set of the barrier system is shown in Figure 132. The maximum lateral permanent set and post deflections were 660 mm (26 in.) at the midspan between post nos. 13 and 14 and 470 mm (18.5 in.) at the centerline of post no. 13, respectively, as measured in the field. The maximum lateral dynamic rail and post deflections were 908 mm (35.7 in.) at the midspan between post nos. 13 and 14 and 670 mm (26.4 in.) at the centerline of post no. 14, respectively, as determined from high-speed digital video analysis. The working width of the system was found to be 1,270 mm (50 in.).

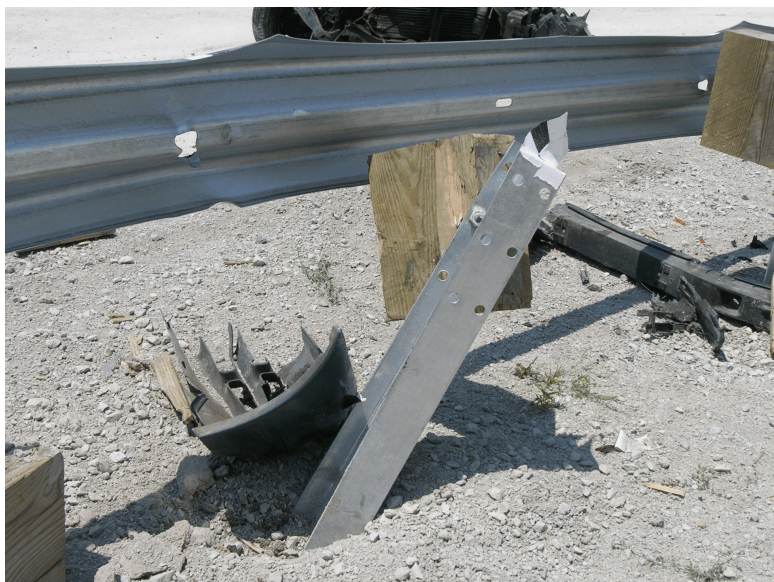
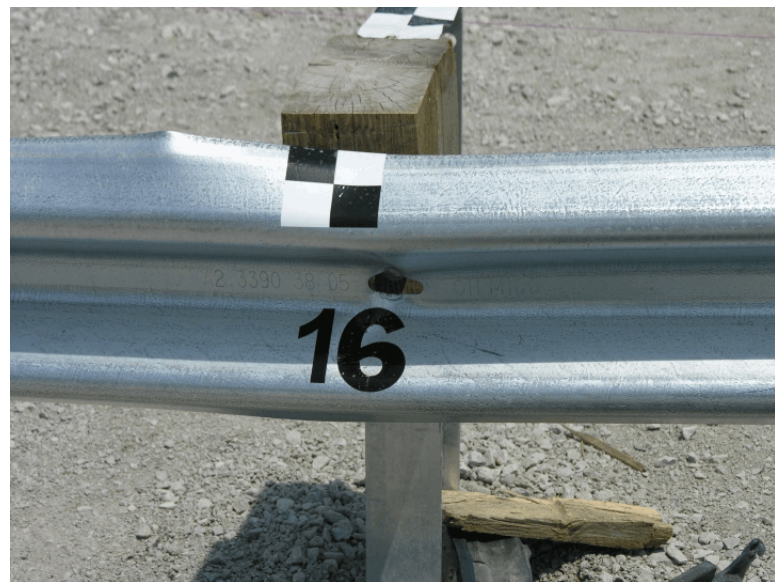
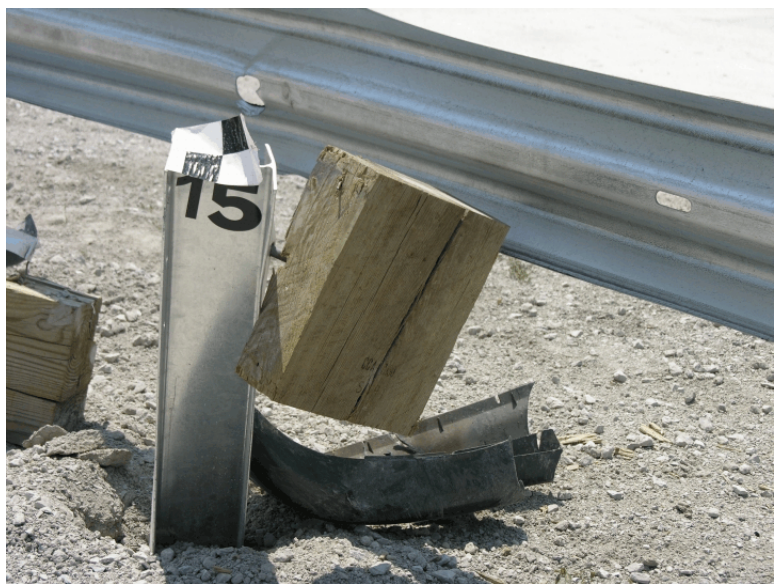
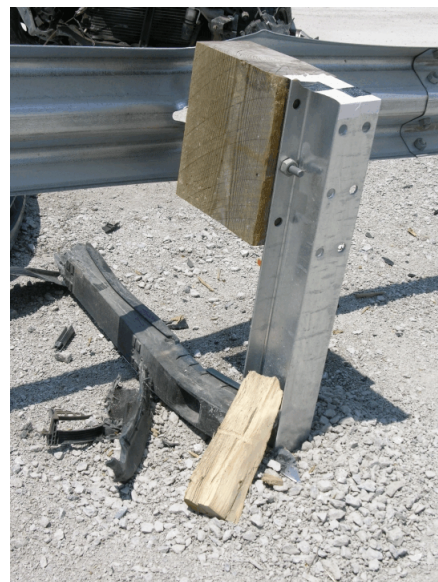
Figure 138. Post Nos. 15 and 16 Damage, Test FR-5

The wooden blockouts at post nos. 3 through 12 and 16 were rotated slightly, while still attached to the post. The wooden blockouts at post nos. 13 and 14 were fractured and removed from the posts, while the blockout at post no. 15 was fractured but remained attached to the post.

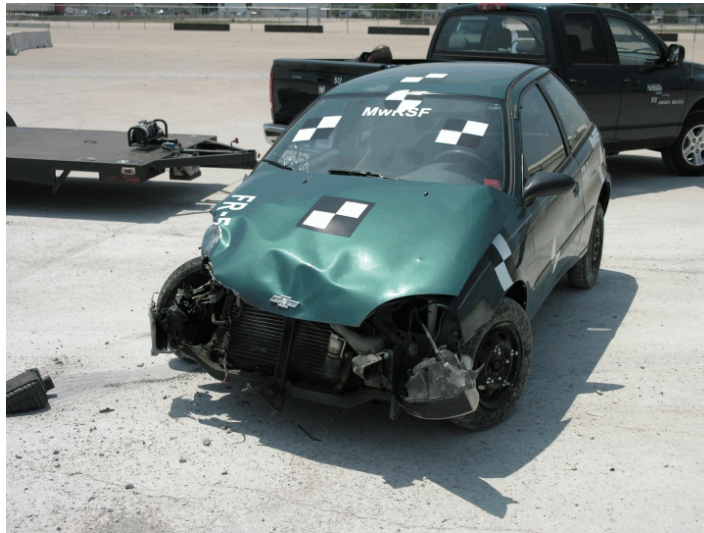
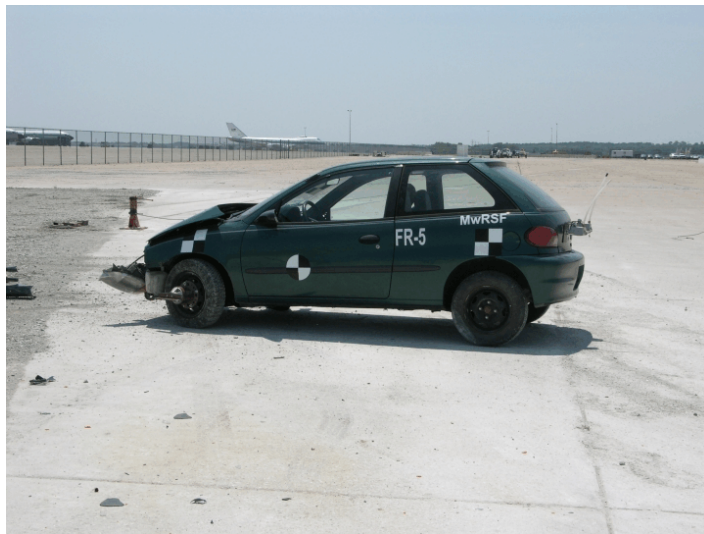
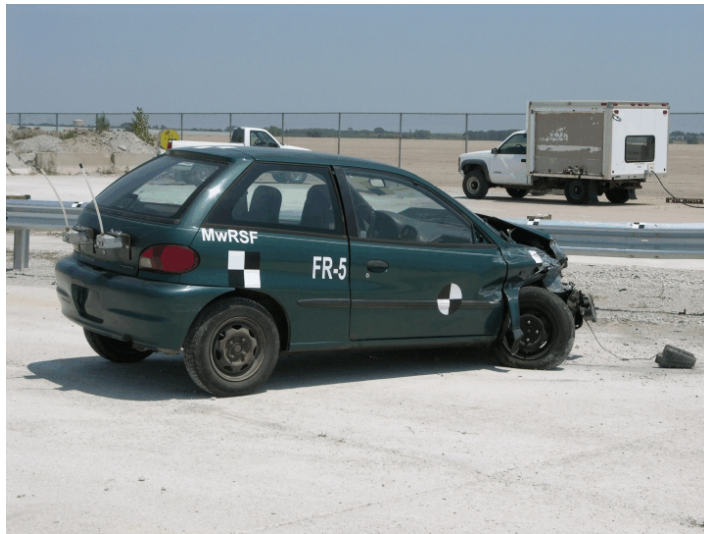
Figure 141. Vehicle Damage, Test FR-5

Exterior vehicle damage was moderate, as shown in Figures 141 through 145. Occupant compartment deformations to the right side and center of the floorboard were judged insufficient to cause serious injury to the vehicle occupants. The occupant compartment deformation is shown in Figure 145. Complete occupant compartment deformations and the corresponding locations are provided in Appendix M.

Damage was concentrated on the right-front corner of the vehicle. The right-front quarter panel, bumper, and radiator were deformed and crushed inward toward the engine compartment. Significant sheet metal tears occurred to the right-front corner of the hood, the right-front quarter panel, and the right door panel. The right-side door could not be opened. The front of the hood was crushed, deformed, and shifted to the right side, causing the right-side hood clips to fracture. Dents and scratches occurred to the entire right side of the vehicle and the exhaust system. The bumper cover disengaged from the vehicle. The right-side headlight was fractured and removed from the housing. The right-front tire was twisted at the wheel attachment and deformed into the wheel well. The right-side lower control arm and steering arm were fractured. The right-side sway bar was bent at the connection to the wheel. The lower-right corner of the windshield encountered “spider-web” cracking due to hood contact. The left side, rear, roof, and all window glass except the windshield remained undamaged.
